Zn-Mg Automotive Steel Coatings

Final Report

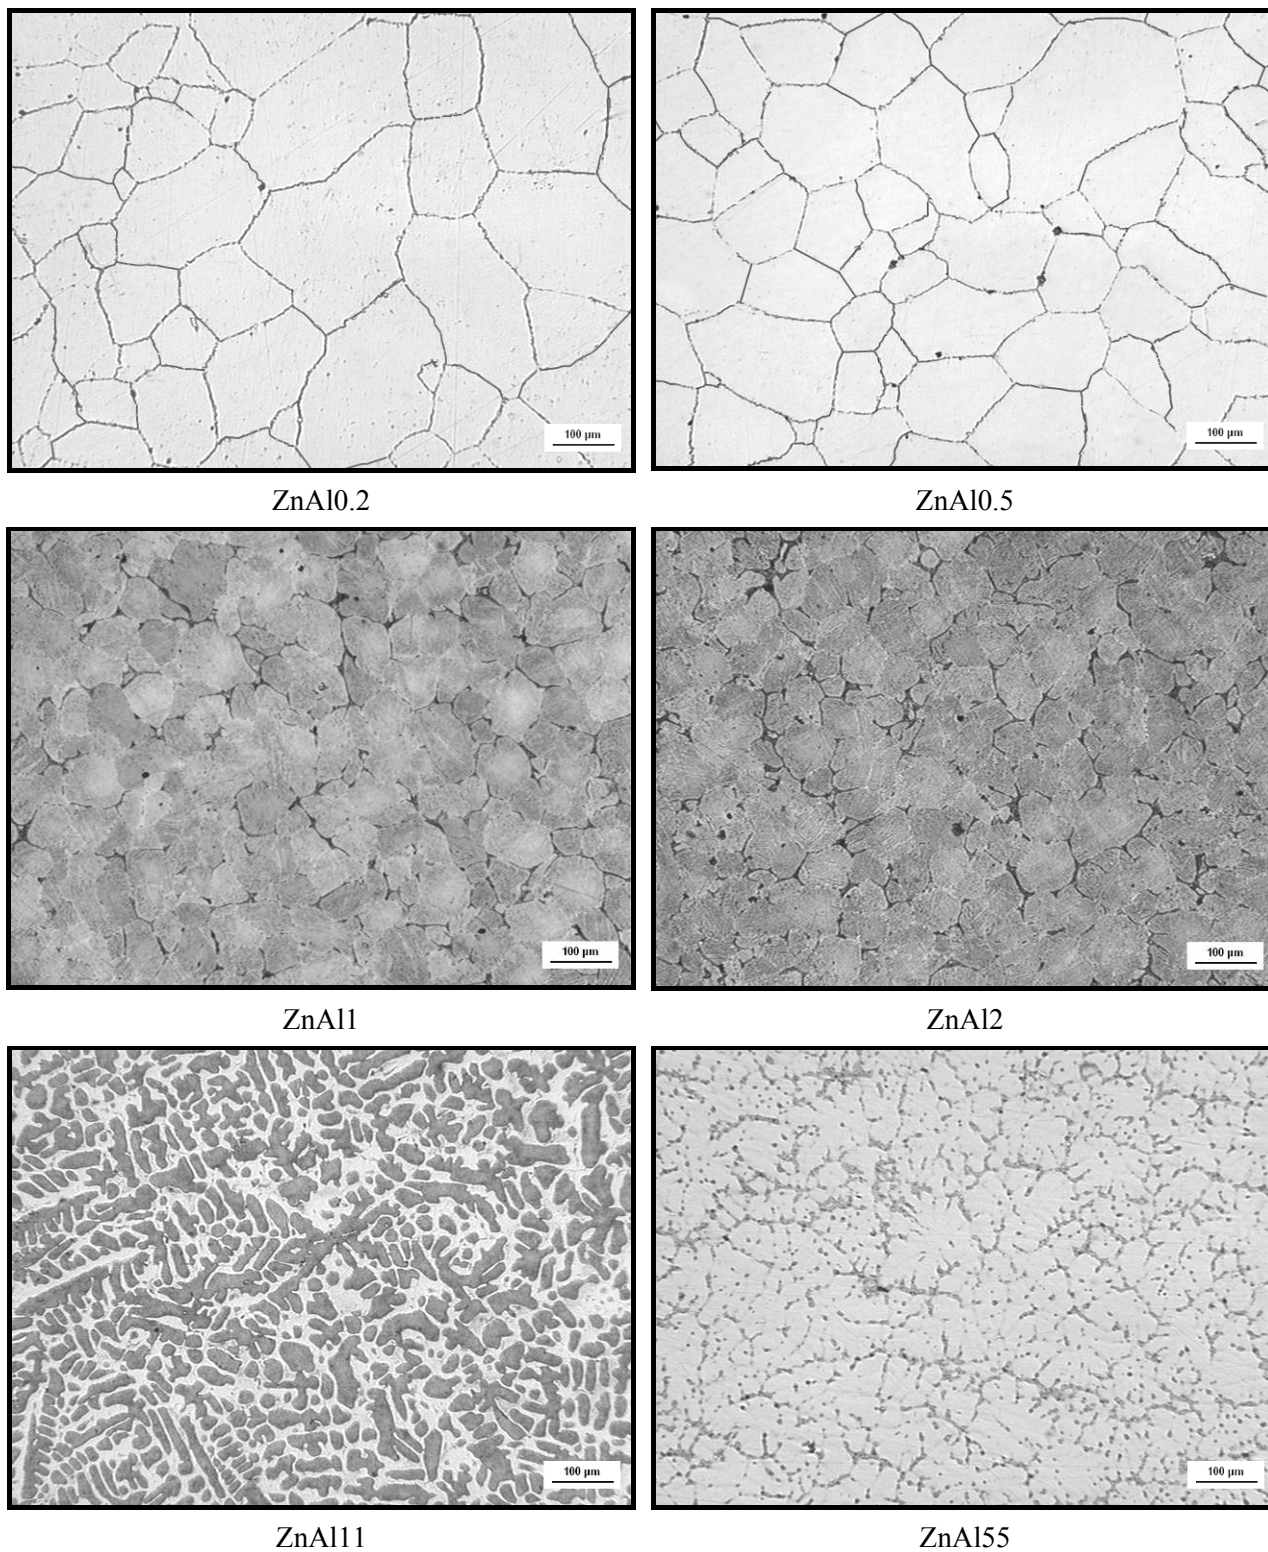
Figure 9 *Microstructure of ZnAl alloys*

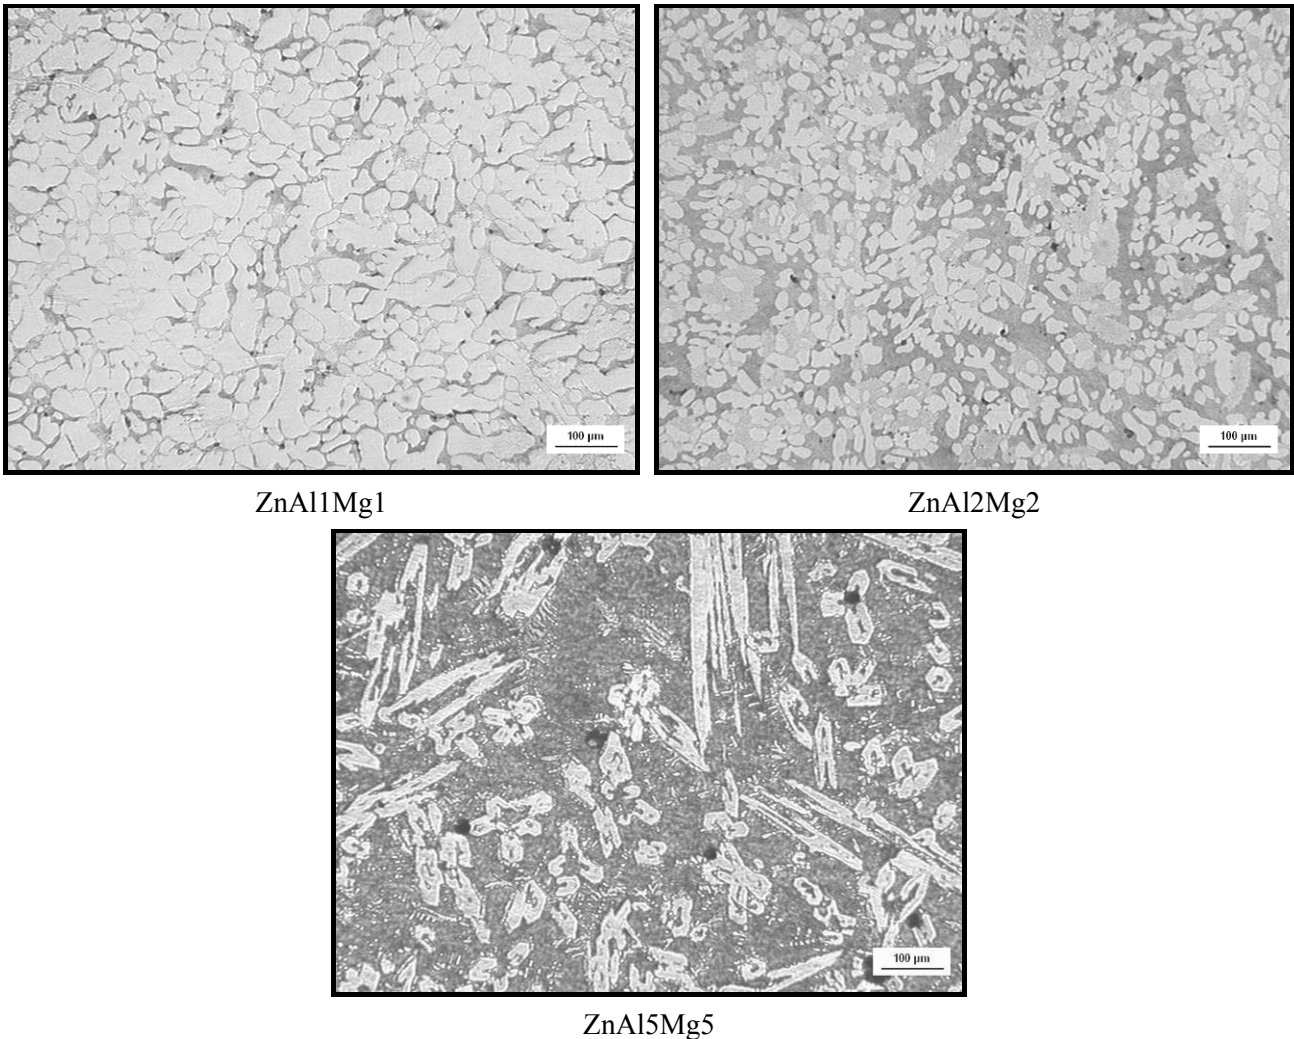
Figure 10 *Microstructure of ZnAlMg alloys*

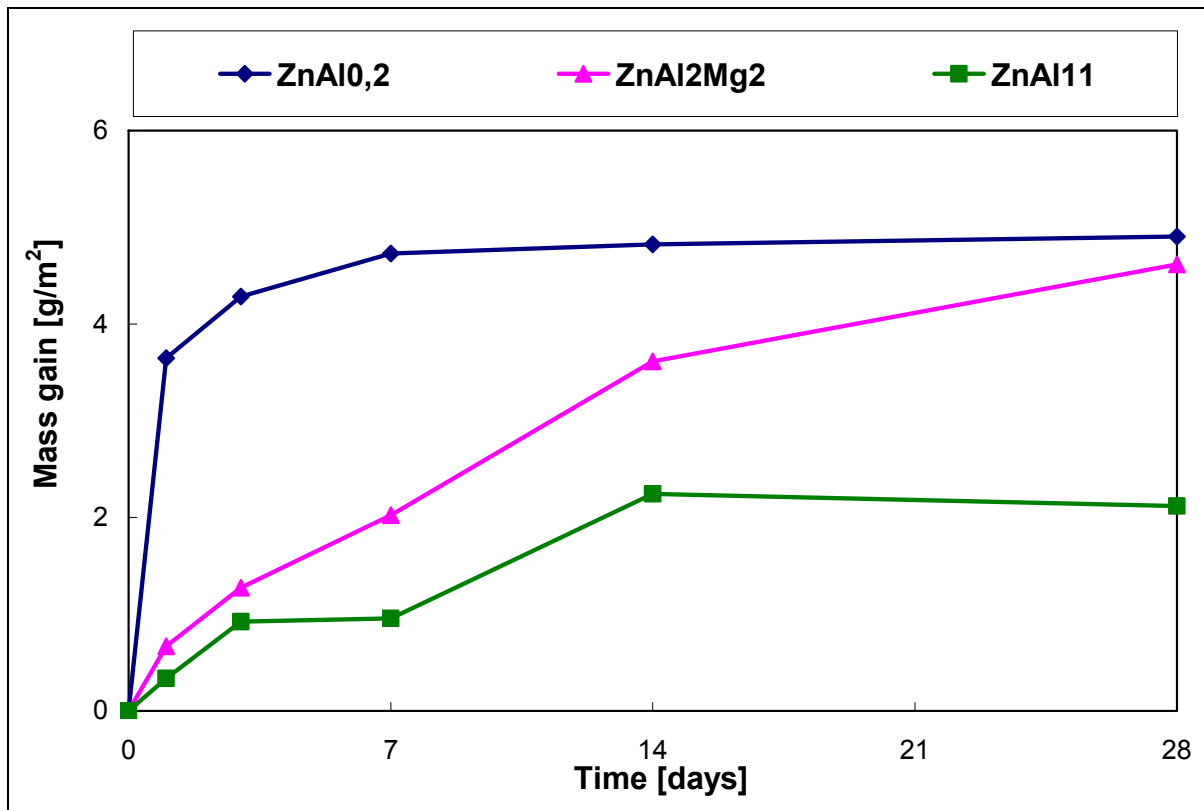
Figure 11 Wet mass gain of some model alloys with chloride contamination of 500 mg/m² during exposure at 20°C and 80 % RH

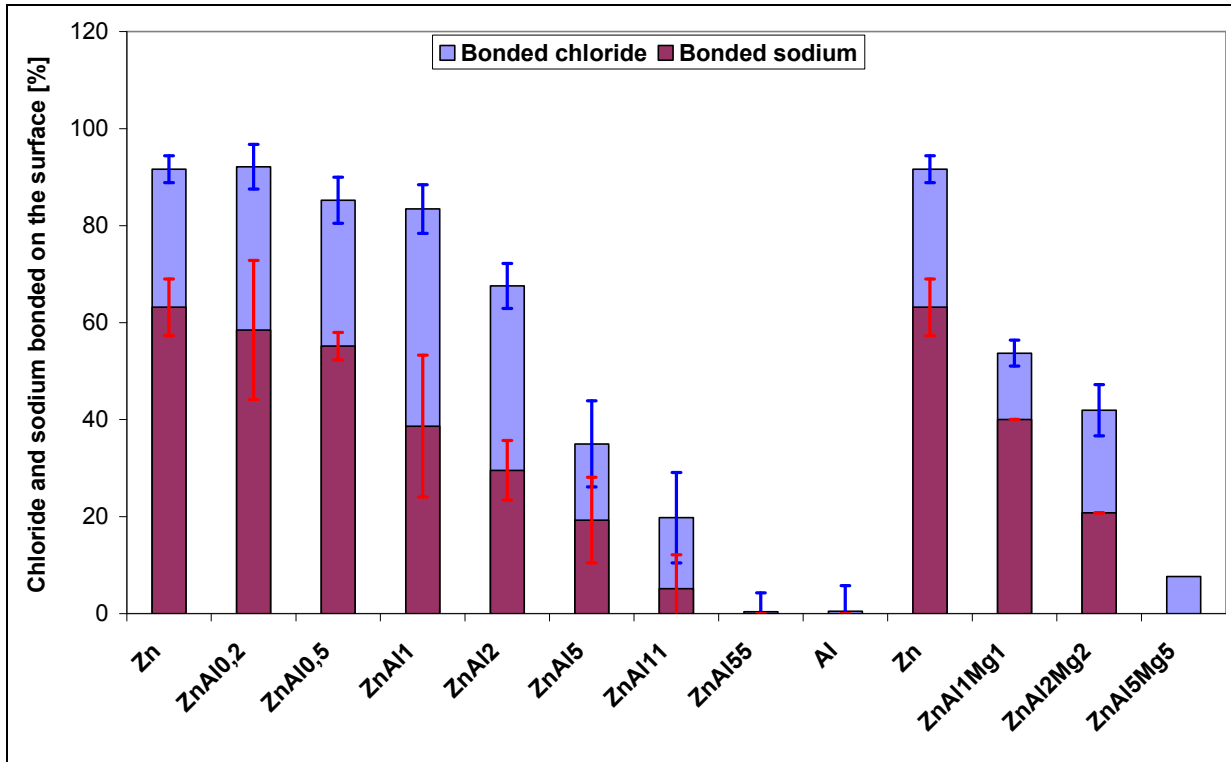
Figure 16 Bonded chloride and bonded sodium on the surface from ion chromatography of water extract of corrosion products; results for model alloys exposed 4 weeks at 20°C and 80 % RH contaminated with NaCl at 1400 mg/m² of chloride and 907 mg/m² of sodium

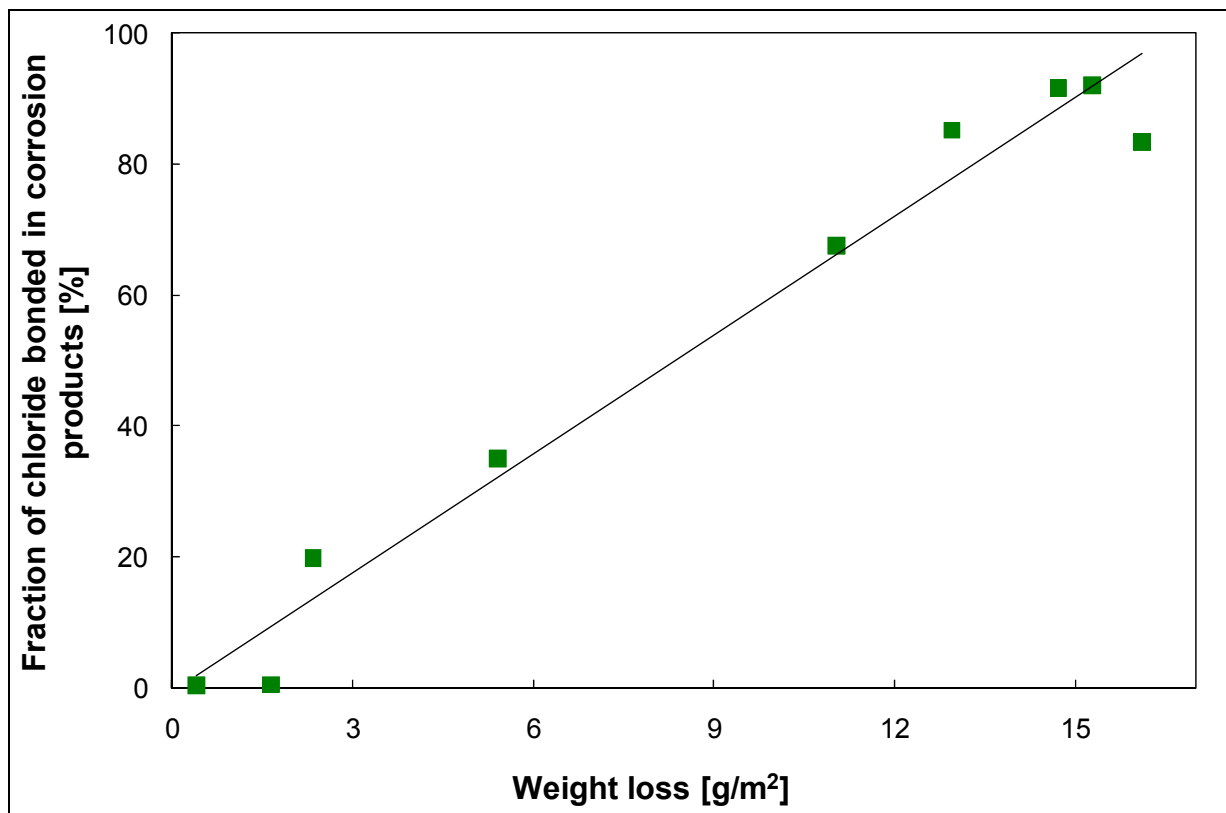
Figure 17 Fraction of chloride bonded in corrosion products versus weight loss for model ZnAl and ZnAlMg alloys

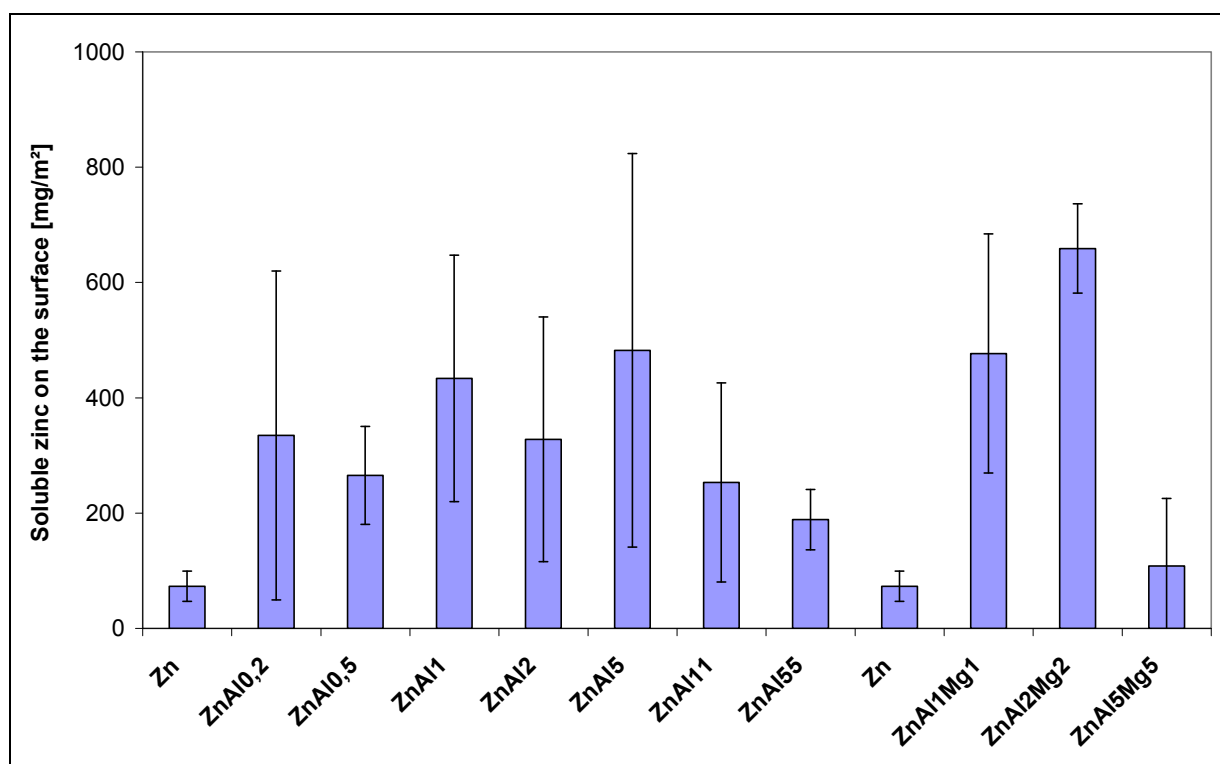
Figure 18 Soluble zinc from ion chromatography of water extract of corrosion products; results for model alloys exposed 4 weeks at 20°C and 80 % RH and contaminated with 1400 mg/m² of chloride

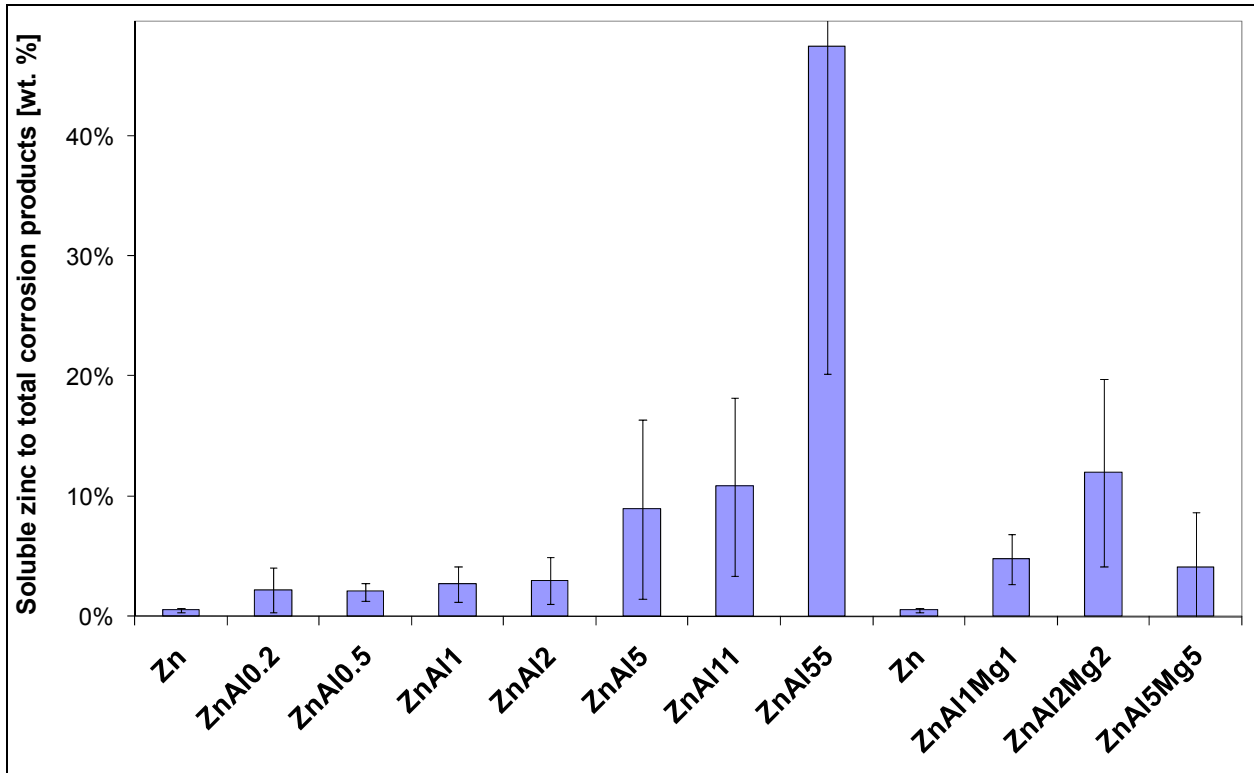
Figure 19 Ratio of soluble zinc to weight loss (total corroded metal); results for model alloys exposed for 4 weeks at 20°C and 80 % RH and contaminated with 1400 mg/m² of chloride.

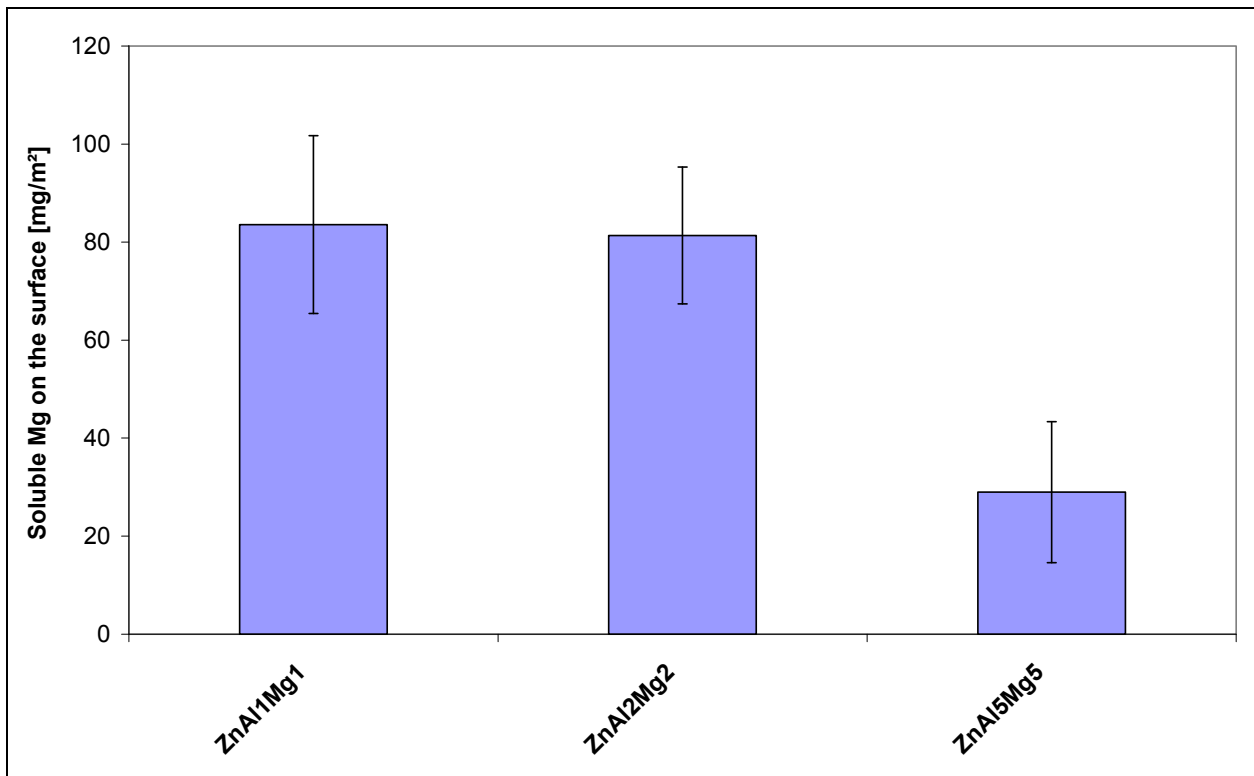
Figure 20 Soluble magnesium on the surface from ion chromatography of water extract of corrosion products; results for ZnAlMg model alloys exposed 4 weeks at 20°C and 80 % RH and contaminated with 1400 mg/m² of chloride

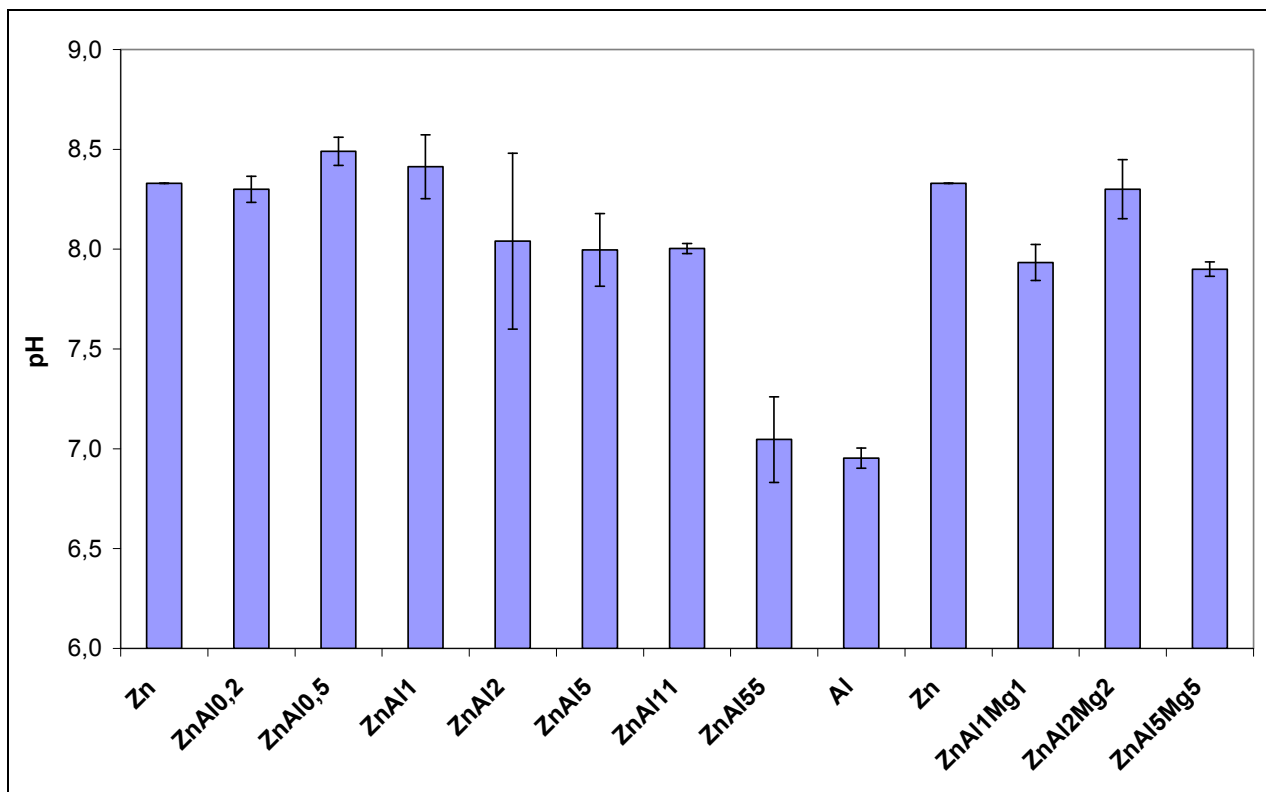
Figure 21 pH of water extracts obtained by dissolving corrosion products from model alloys exposed for 4 weeks at 20°C and 80 % RH and contaminated with 1400 mg/m² of chloride

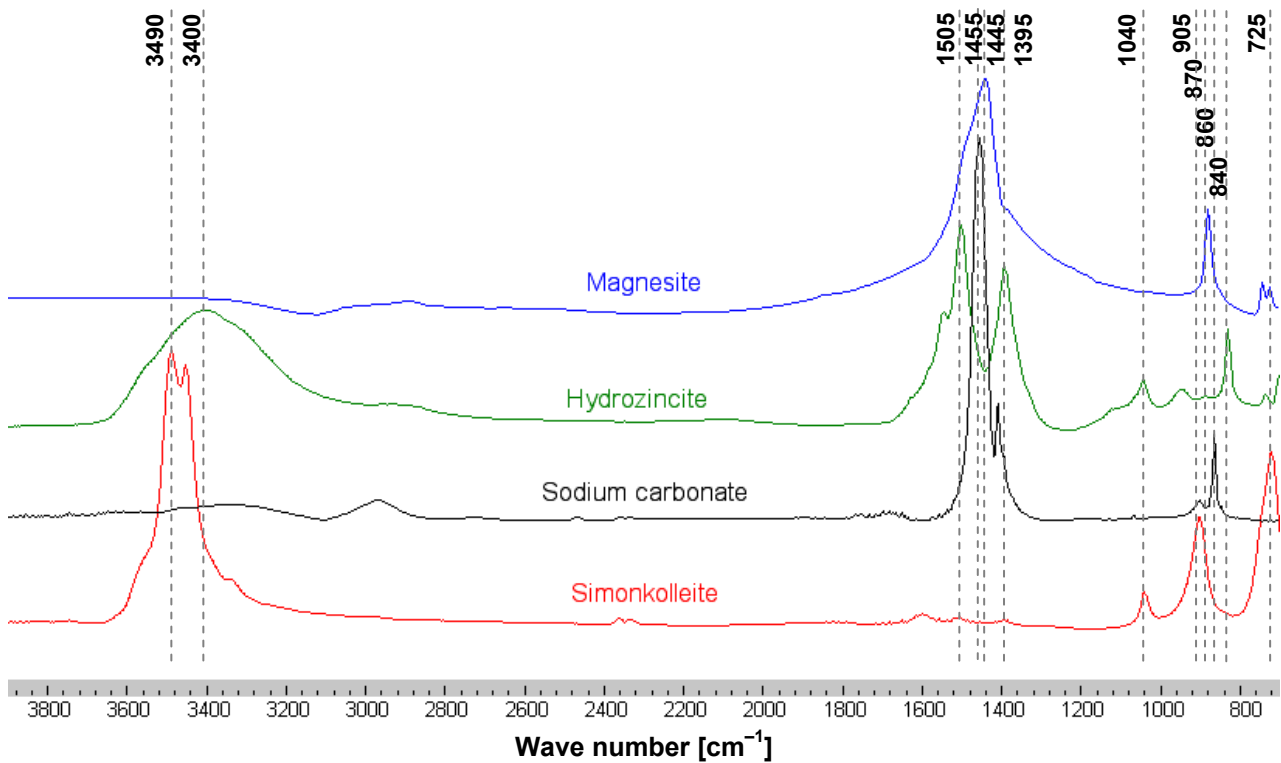
Figure 22 Infrared transmission spectra of reference minerals

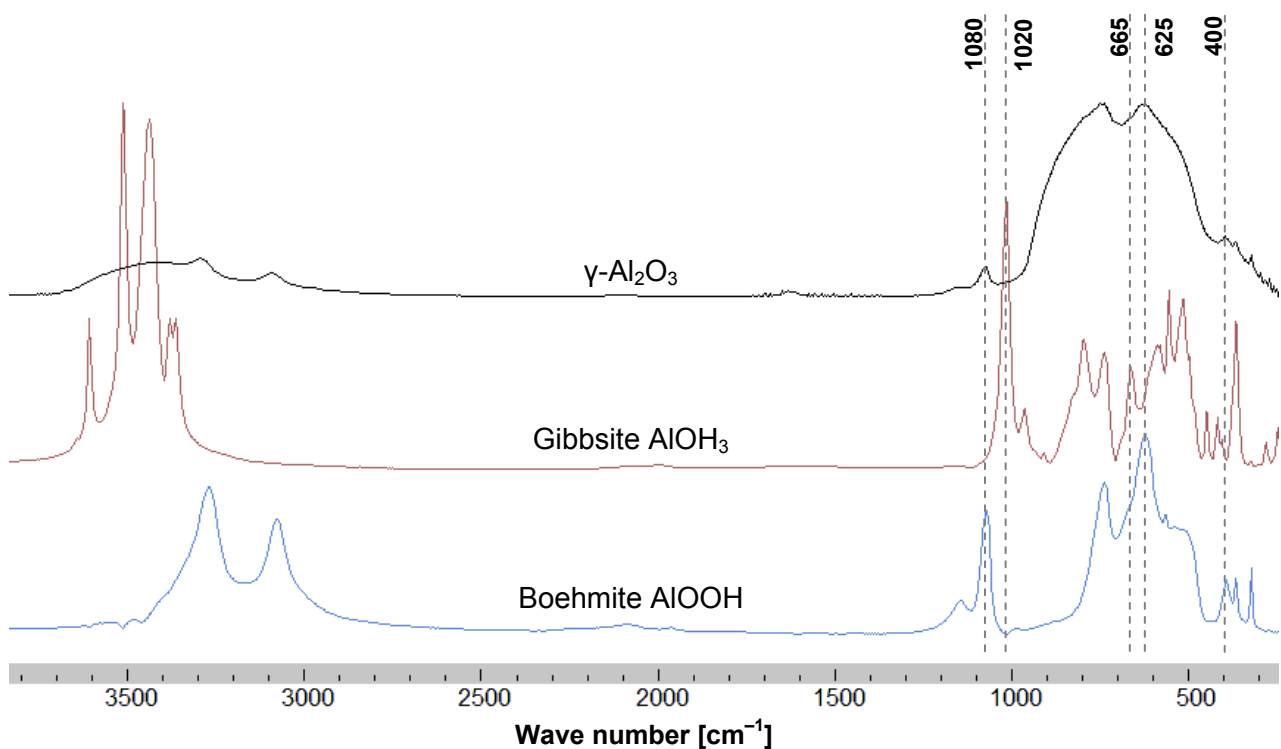
Figure 23 Infrared transmission spectra of aluminum-based reference minerals

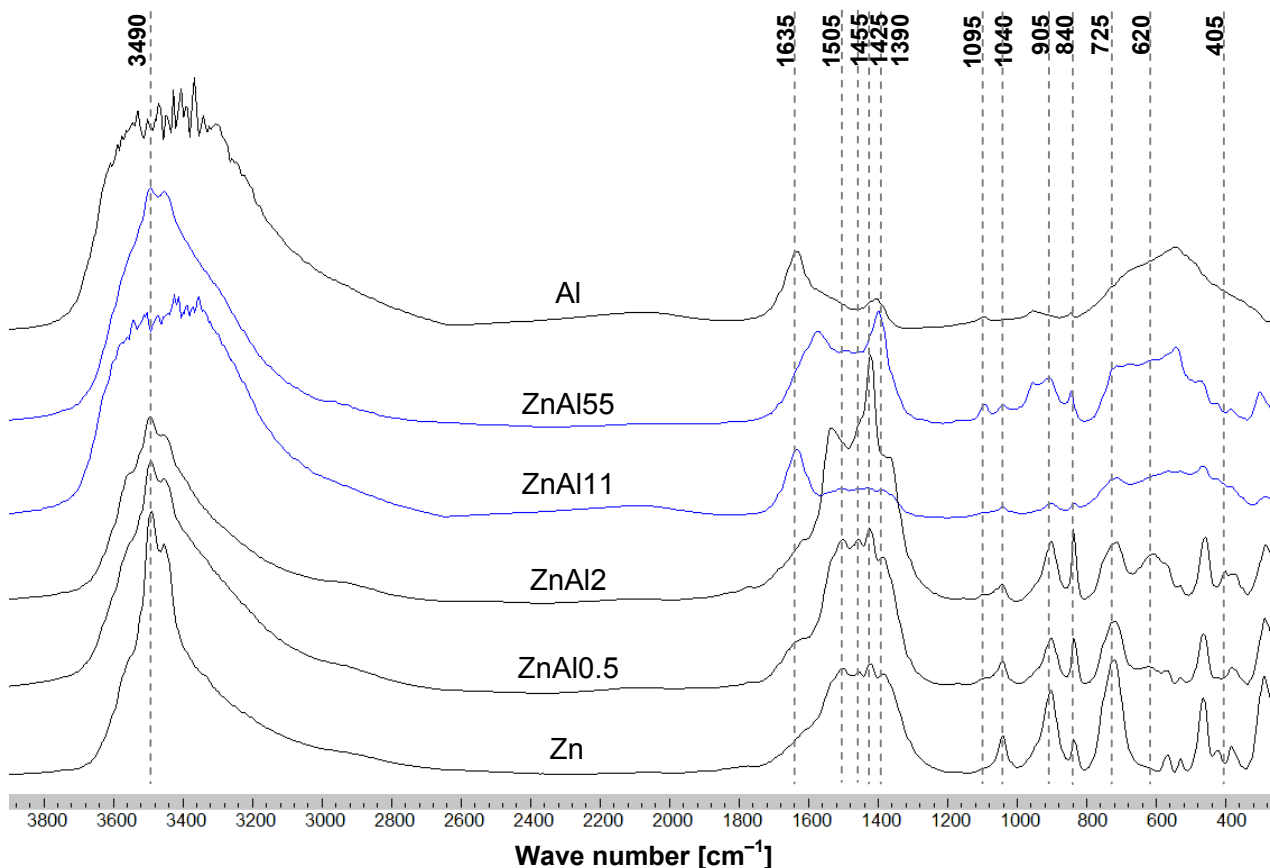
Figure 24 Infrared transmission spectra of corrosion products collected on model alloys of Zn, ZnAl0.5 , ZnAl2 , ZnAl11 , ZnAl15 , and Al with deposited sodium chloride at the chloride concentration of 1400 mg/m^2 exposed for 28 days at 20°C and at 80 % RH

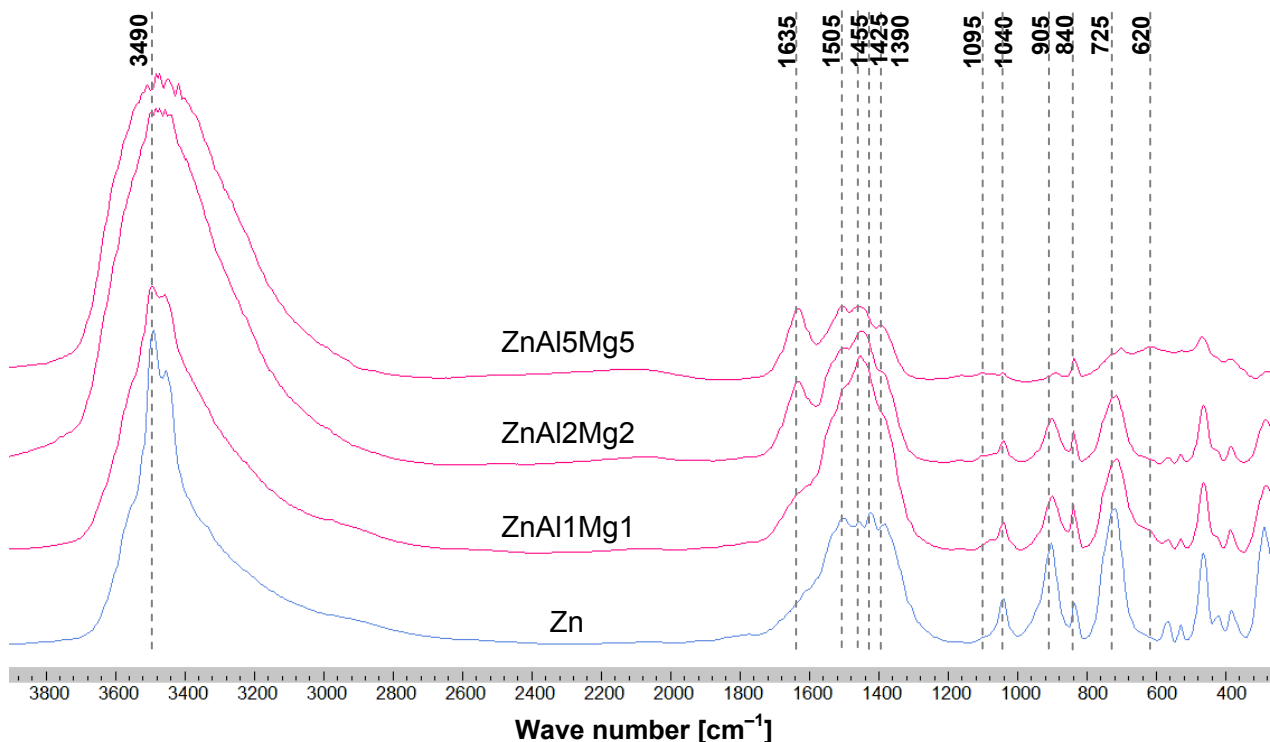
Figure 26 Infrared transmission spectra of corrosion products collected on model alloys of Zn, ZnAl1Mg1, ZnAl2Mg2, and ZnAl5Mg5 with deposited sodium chloride at the chloride concentration of 1400 mg/m^2 exposed for 28 days at 20°C and at 80 % RH

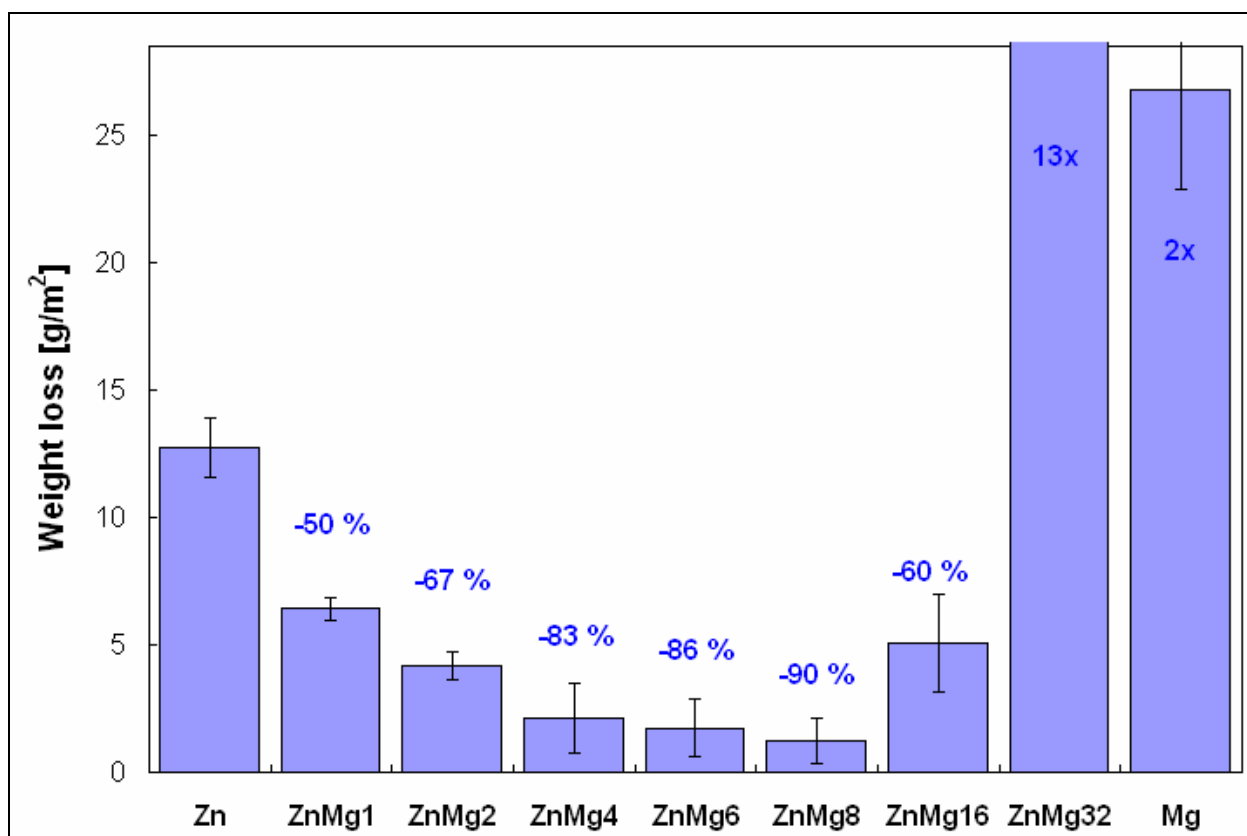
Figure 27 Weight loss of ZnMg model alloys after 4 weeks of exposure at 20°C and 80 % RH; model alloys were contaminated with 1400 mg/m² of chloride; results from [12]

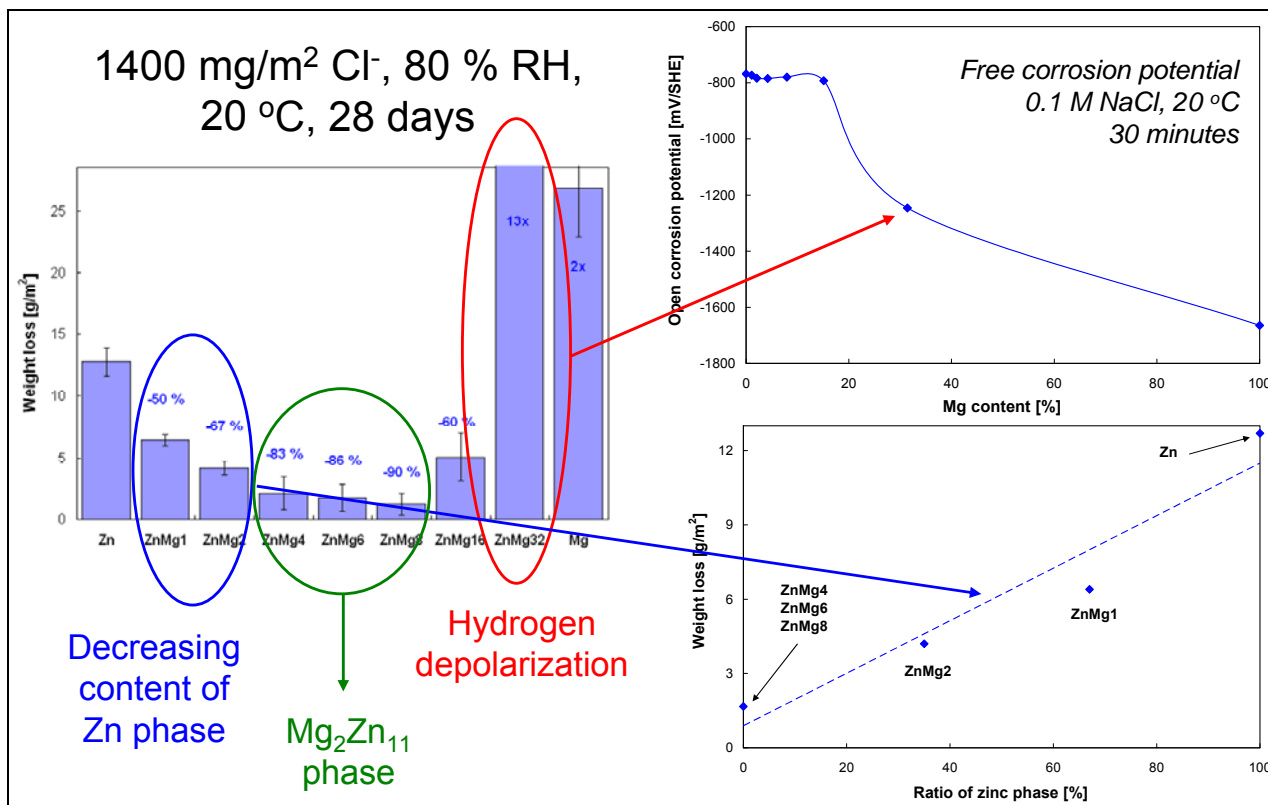
Figure 28 Relation between corrosion resistance and amount of pure Zn phase; free corrosion potential of ZnMg32 showing possible hydrogen depolarization; results from [12]

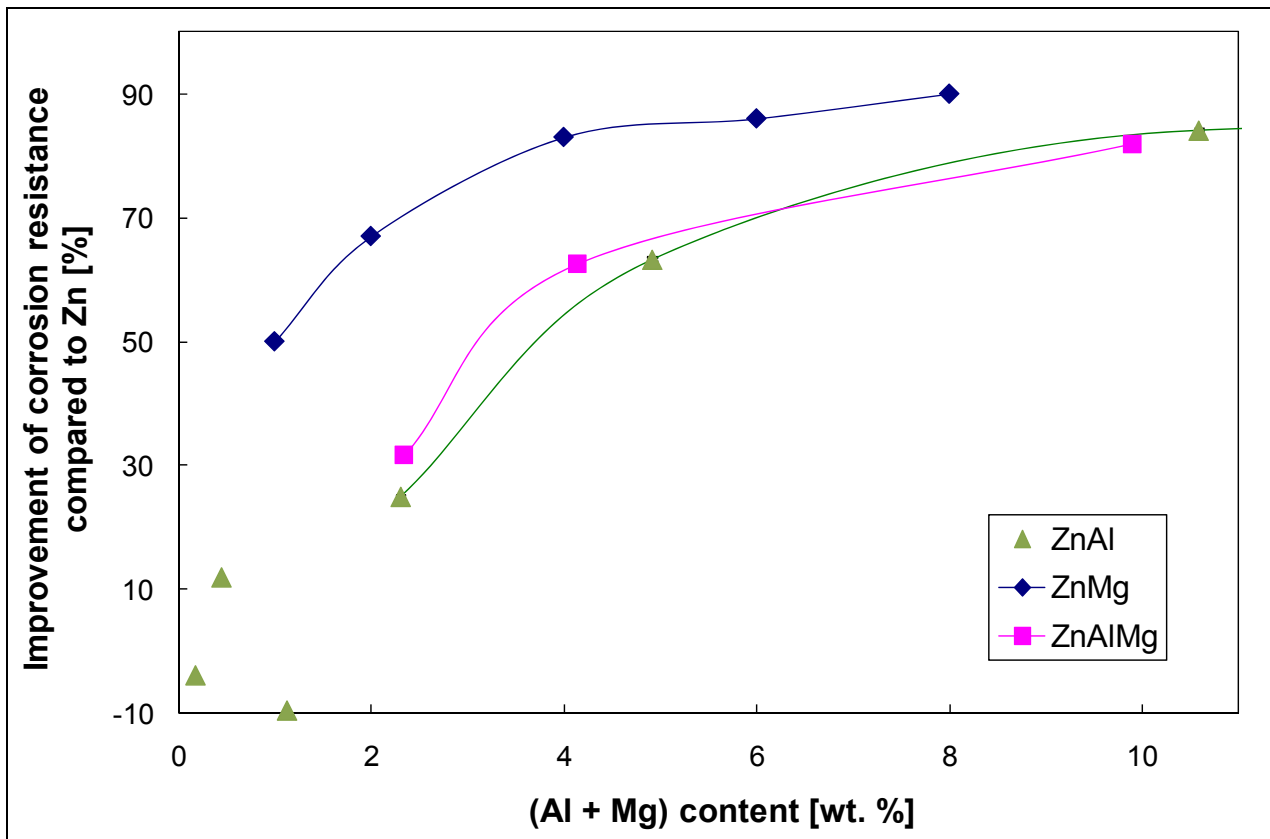
Figure 29 Corrosion resistance improvement compared to zinc as a function of total alloying from 0 to 11 %; ZnAl and ZnAlMg results are from the present study, results for ZnMg model alloys are from [12]

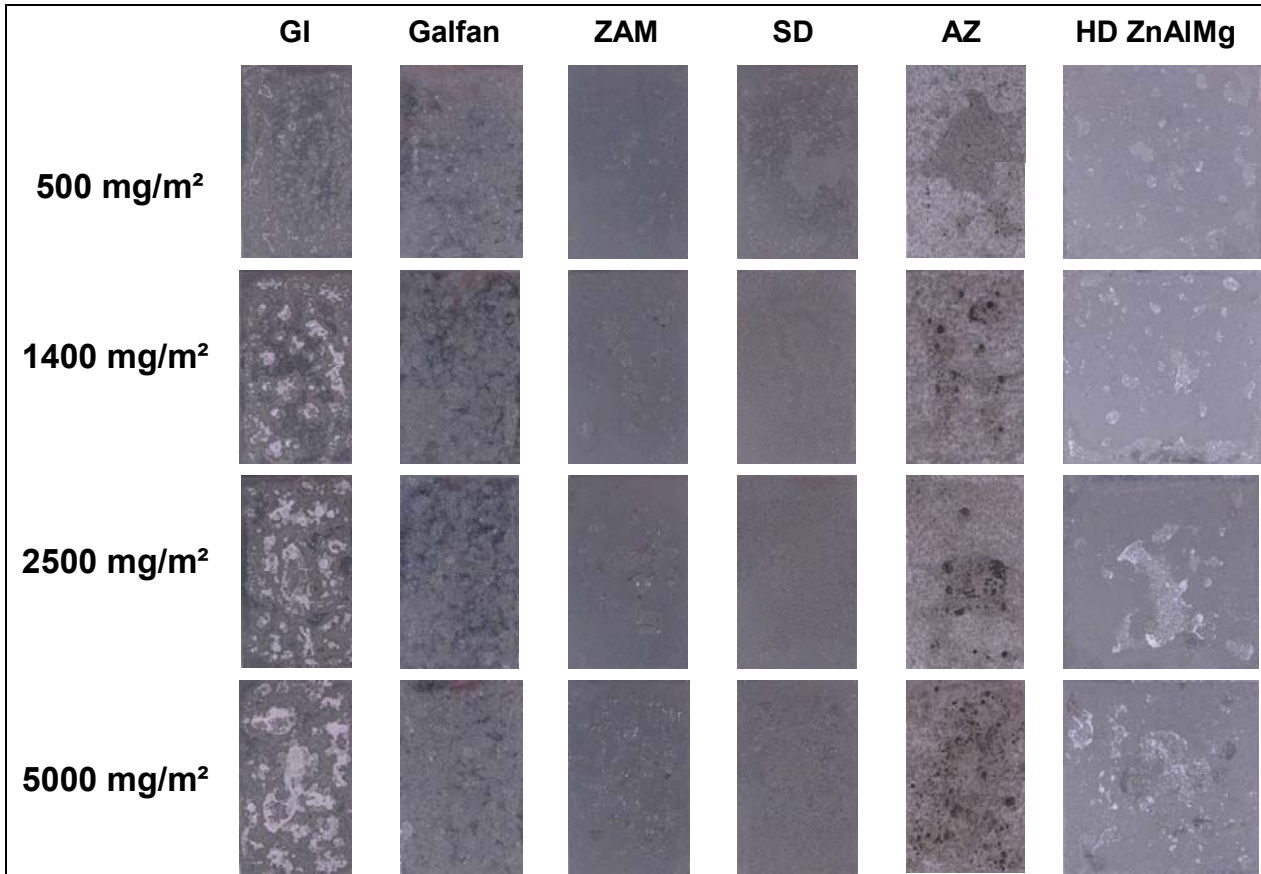
Figure 30 Visual aspect of coated steel sheets after 4 weeks of exposure at 20°C and 80 % RH

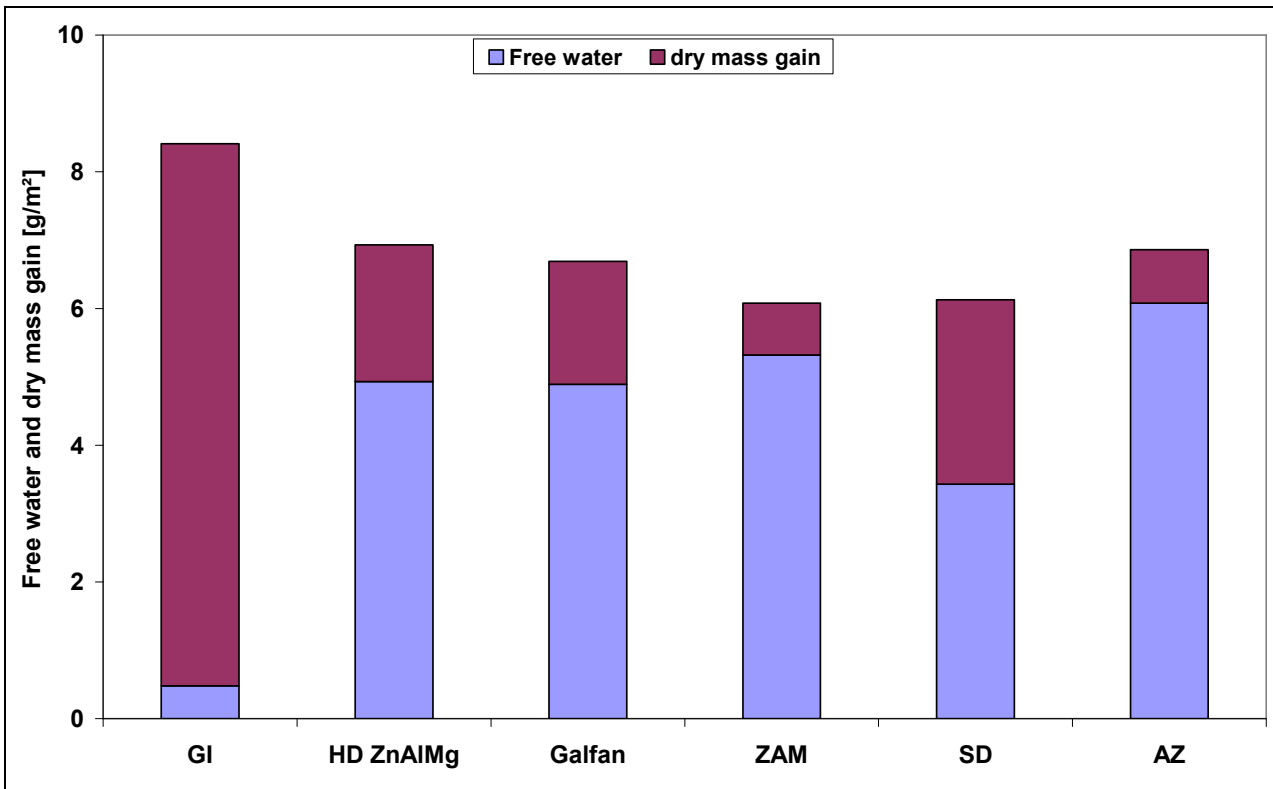
Figure 33 Dry mass gain and amount of free water on surfaces of coated samples contaminated with 1400 mg/m² of chloride after 4 weeks of exposure at 20°C and 80 % RH; the total height of the columns represent the wet mass gain after the test

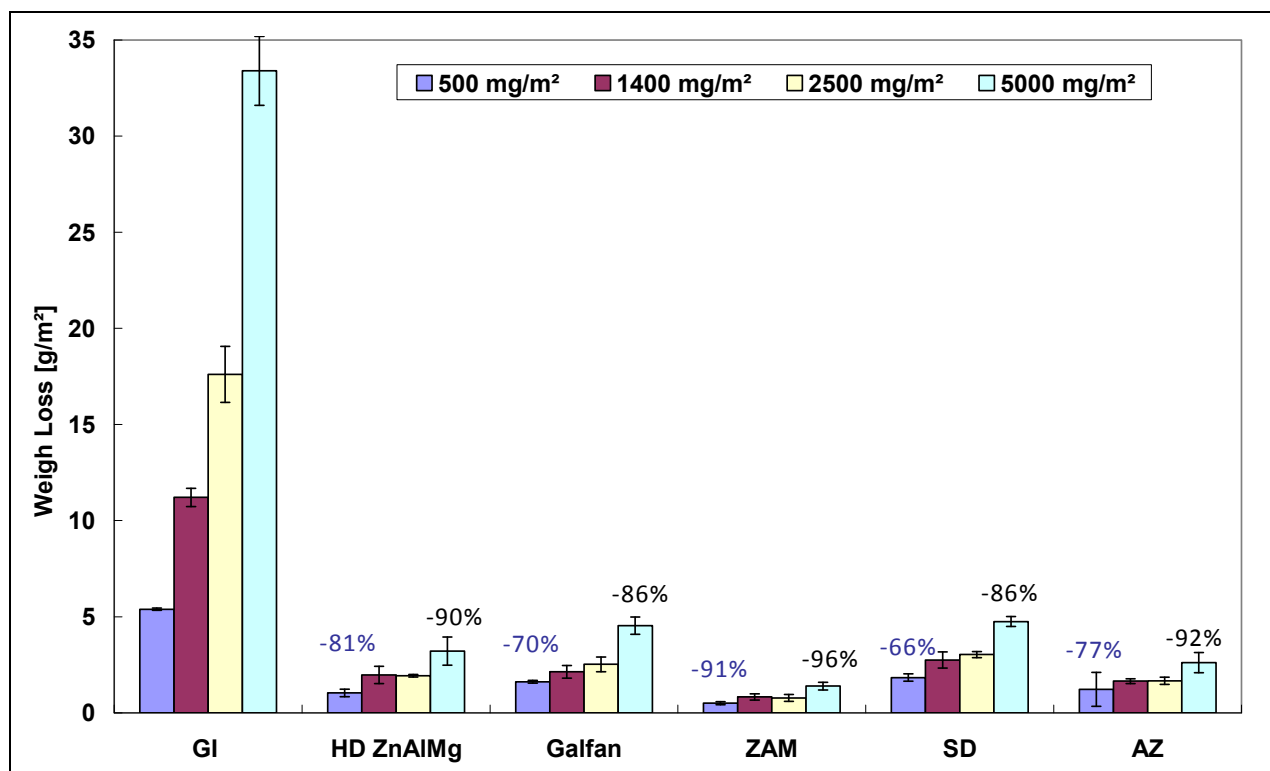
Figure 34 Weight loss of metallic coated steel after 4 weeks of exposure at 20°C and 80 % RH

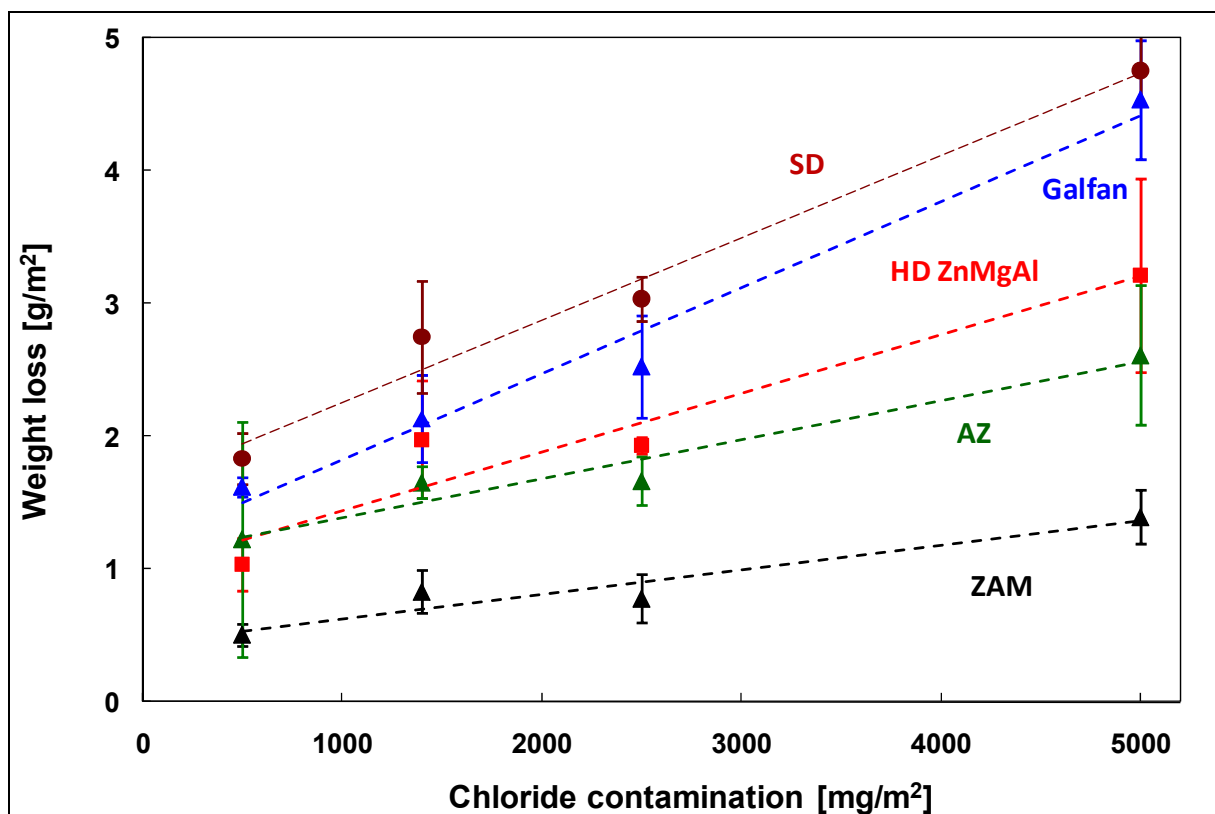
Figure 35 Weight loss vs. chloride contamination for coated steel panels after 4 weeks of exposure at 20°C and 80 % RH

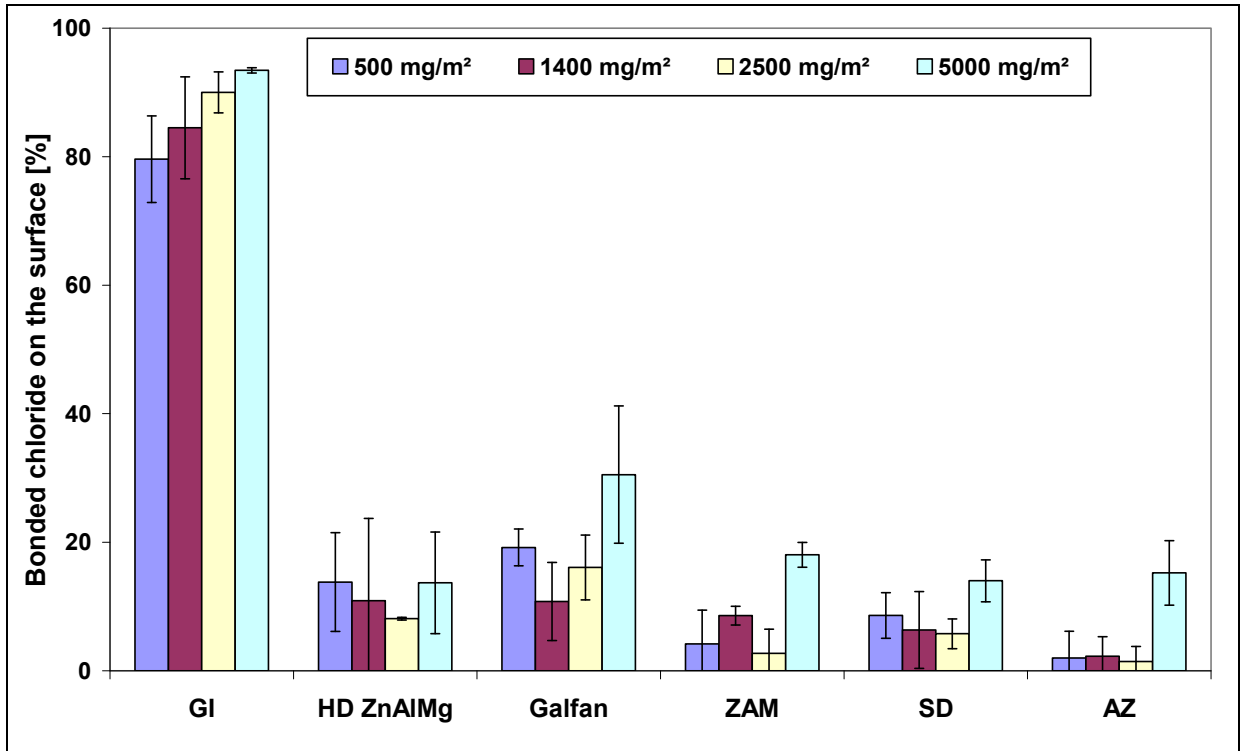
Figure 36 Bonded chloride on the surface from ion chromatography of water extract of corrosion products; results for coated panels exposed 4 weeks at 20°C and 80 % RH and contaminated with 500, 1400, 2500, and 5000 mg/m² of chloride
