Zn-Mg Automotive Steel Coatings

Final Report

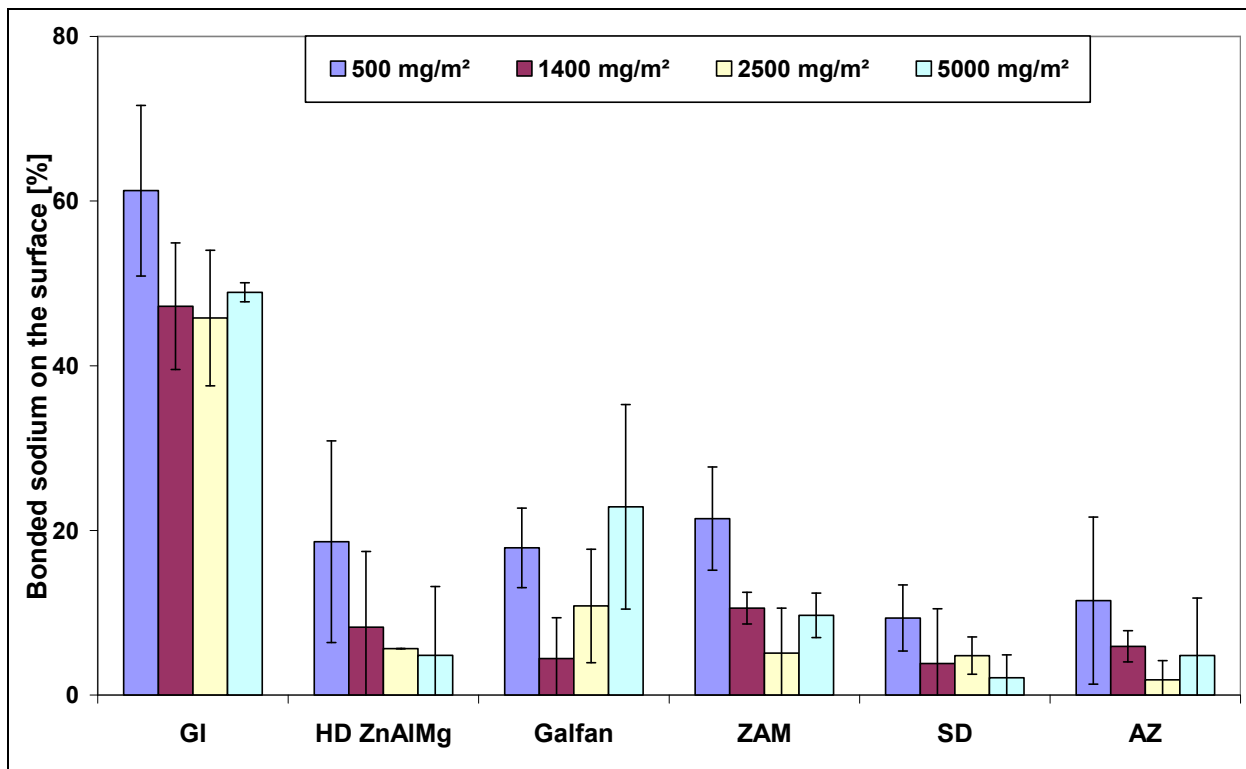
Figure 37 Bonded sodium on the surface from ion chromatography of water extract of corrosion products; results for coated panels exposed 4 weeks at 20°C and 80 % RH and contaminated with 500, 1400, 2500, and 5000 mg/m² of chloride and 324, 907, 1620, and 3240 mg/m² of sodium, respectively

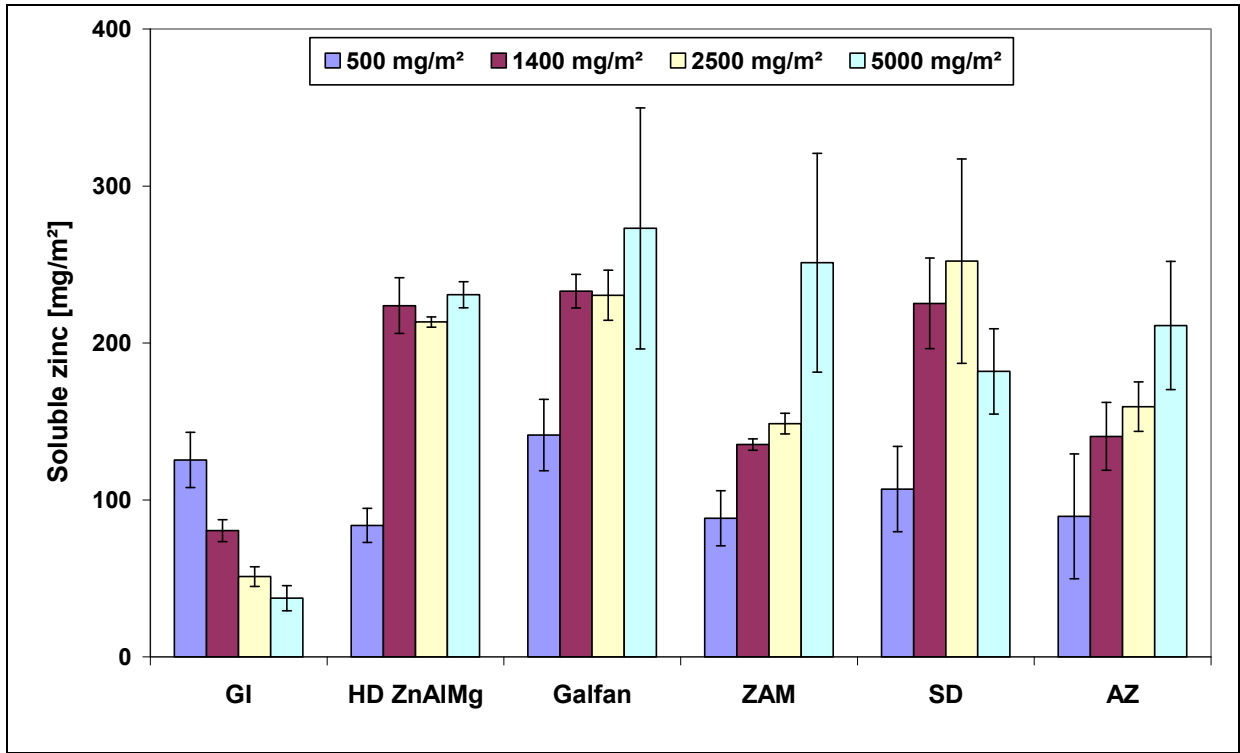
Figure 38 Soluble zinc on the surface from ion chromatography of water extract of corrosion products; results for coated panels exposed 4 weeks at 20°C and 80 % RH and contaminated with 500, 1400, 2500, and 5000 mg/m² of chloride

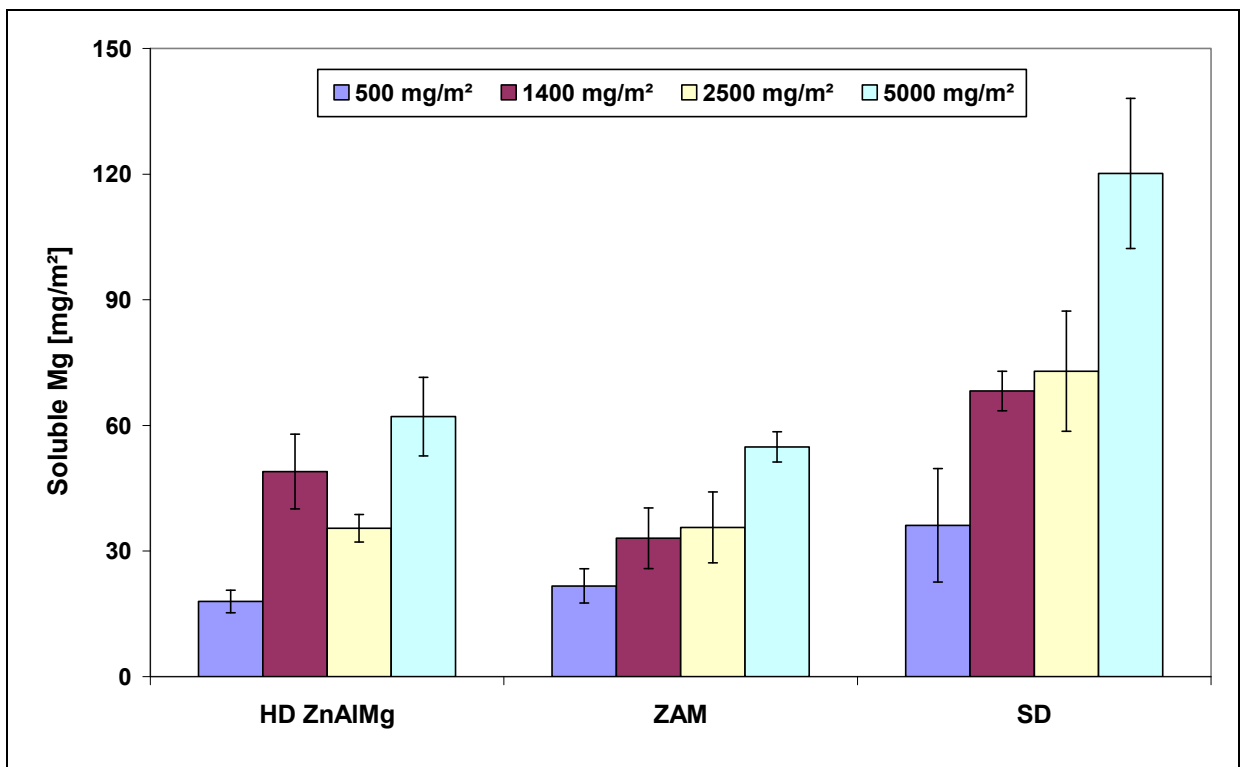
Figure 39 Soluble magnesium on the surface from ion chromatography of water extract of corrosion products; results for coated panels exposed 4 weeks at 20°C and 80 % RH and contaminated with 500, 1400, 2500, and 5000 mg/m² of chloride

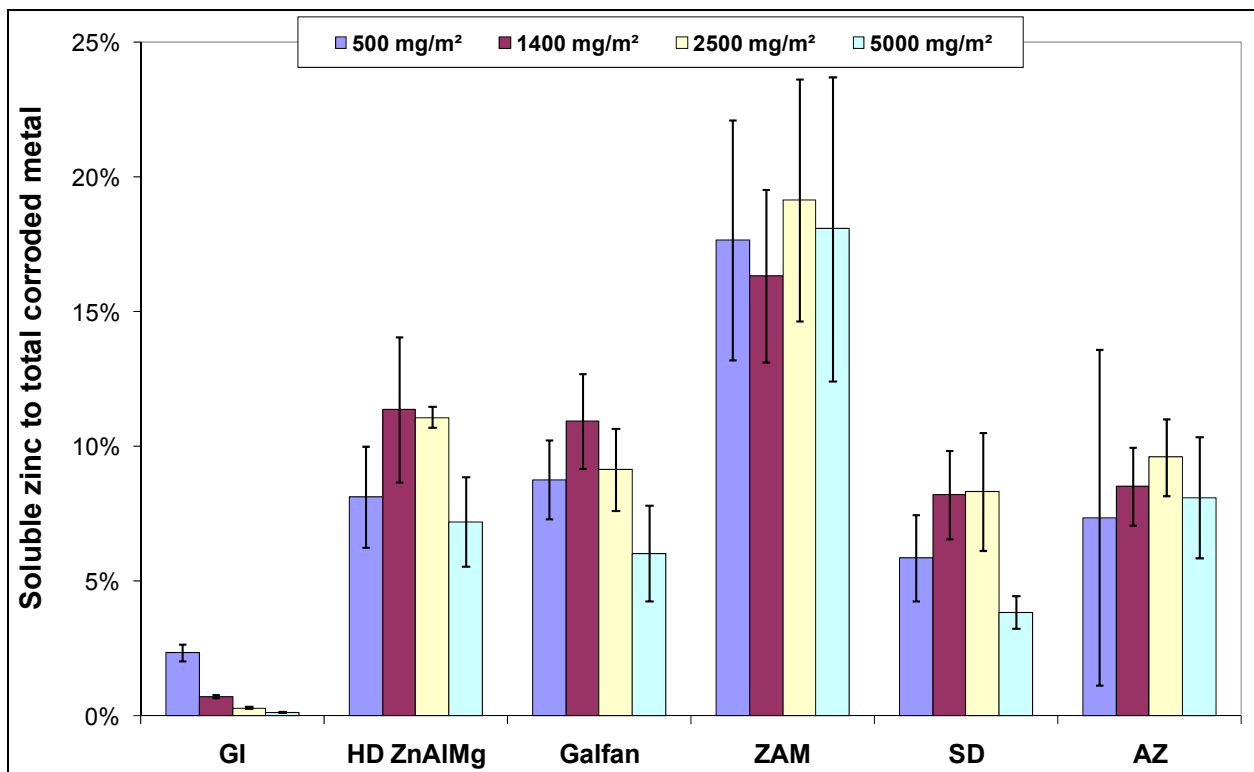
Figure 40 Ratio of soluble zinc to weight loss (total corroded metal); results for coated panels exposed 4 weeks at 20°C and 80 % RH and contaminated with 500, 1400, 2500, and 5000 mg/m² of chloride

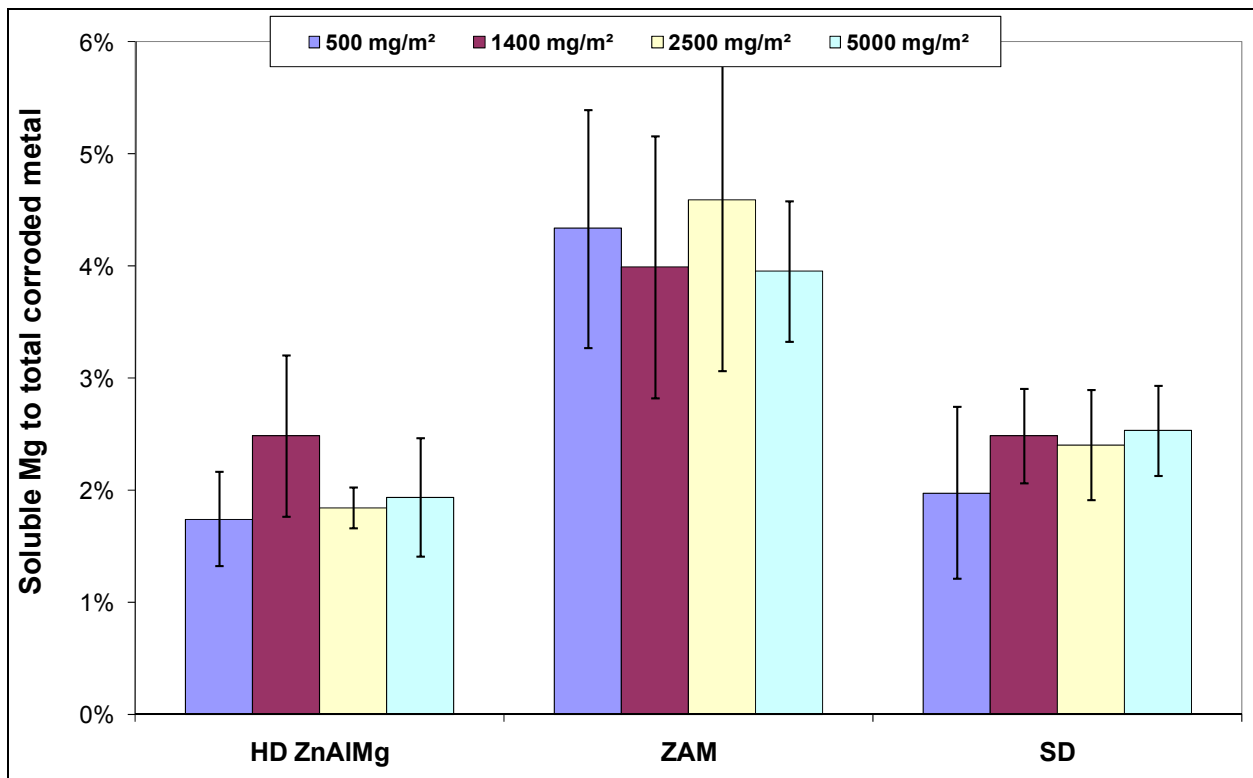
Figure 41 Ratio of soluble magnesium to weight loss (total corroded metal); results for coated panels exposed 4 weeks at 20°C and 80 % RH and contaminated with 500, 1400, 2500, and 5000 mg/m² of chloride

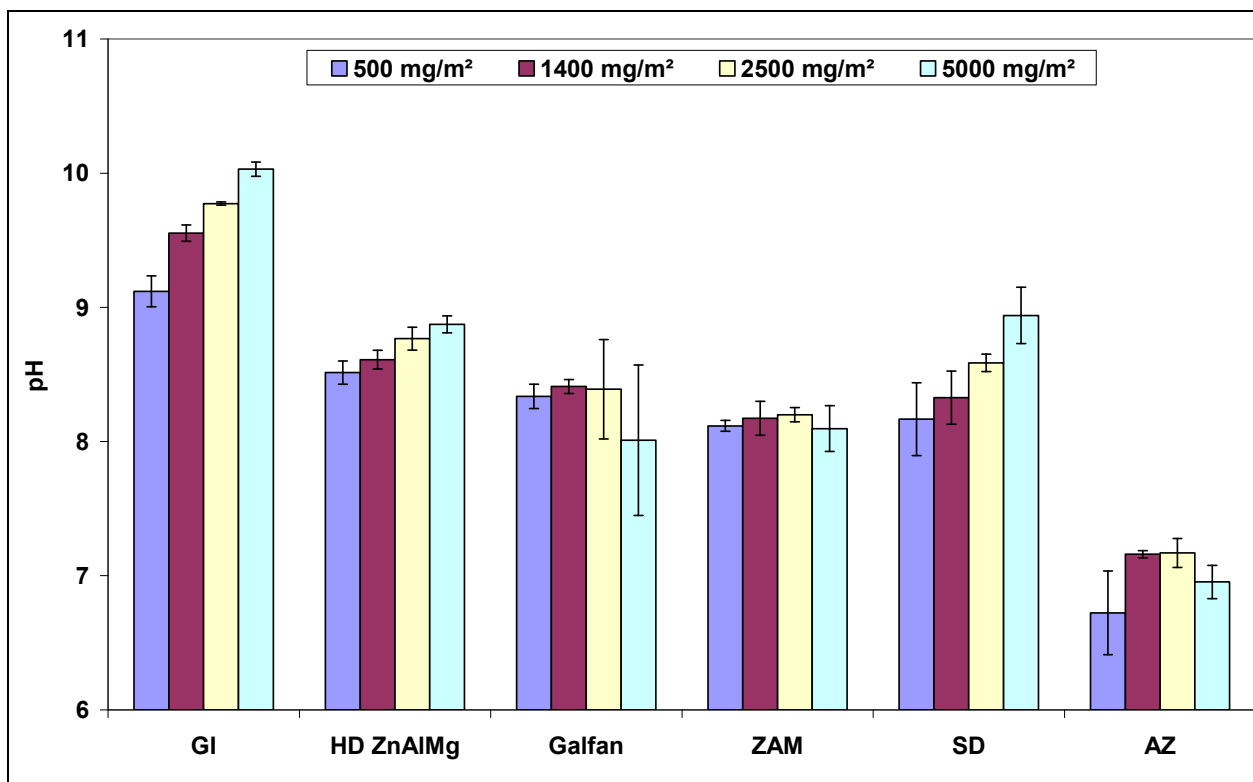
Figure 42 pH of water extracts obtained by dissolving corrosion products

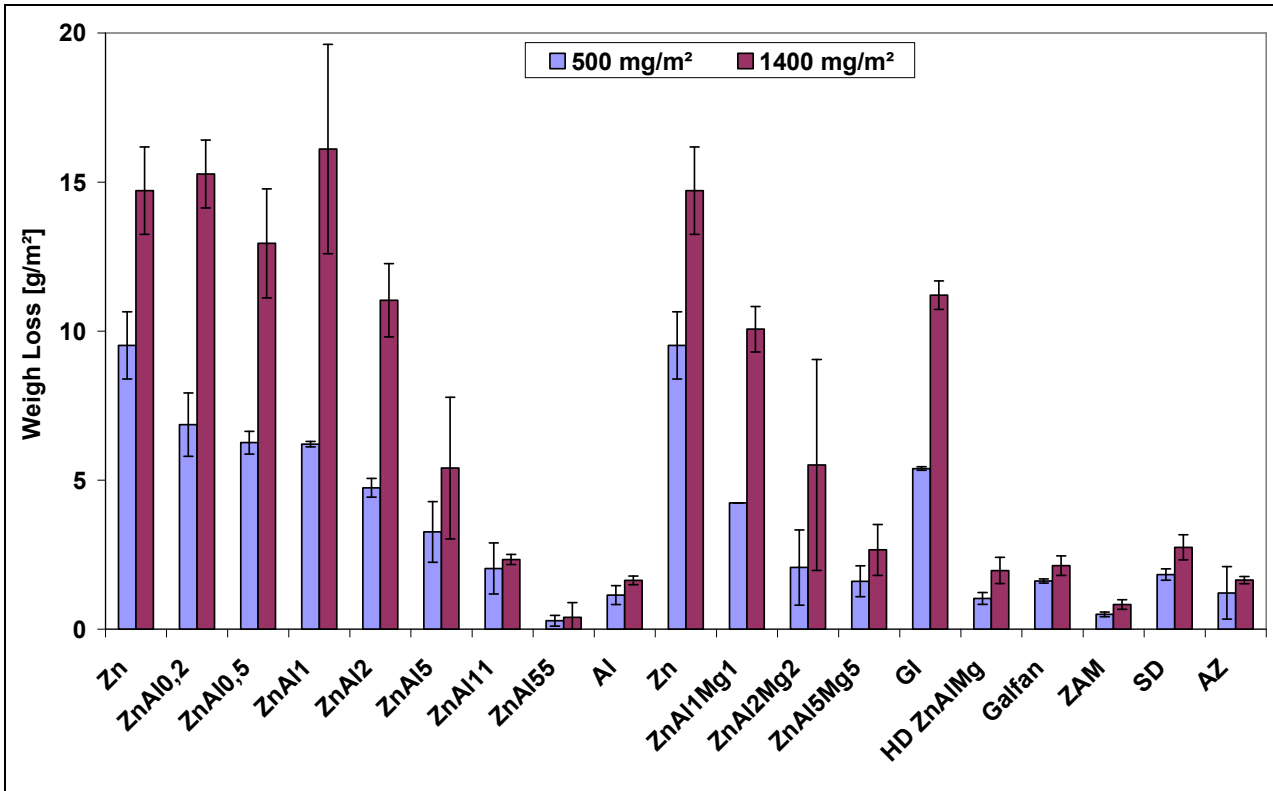
Figure 43 Weight loss comparison between commercial metallic coated steel and model alloys after 4 weeks of exposure at 20°C and 80 % RH

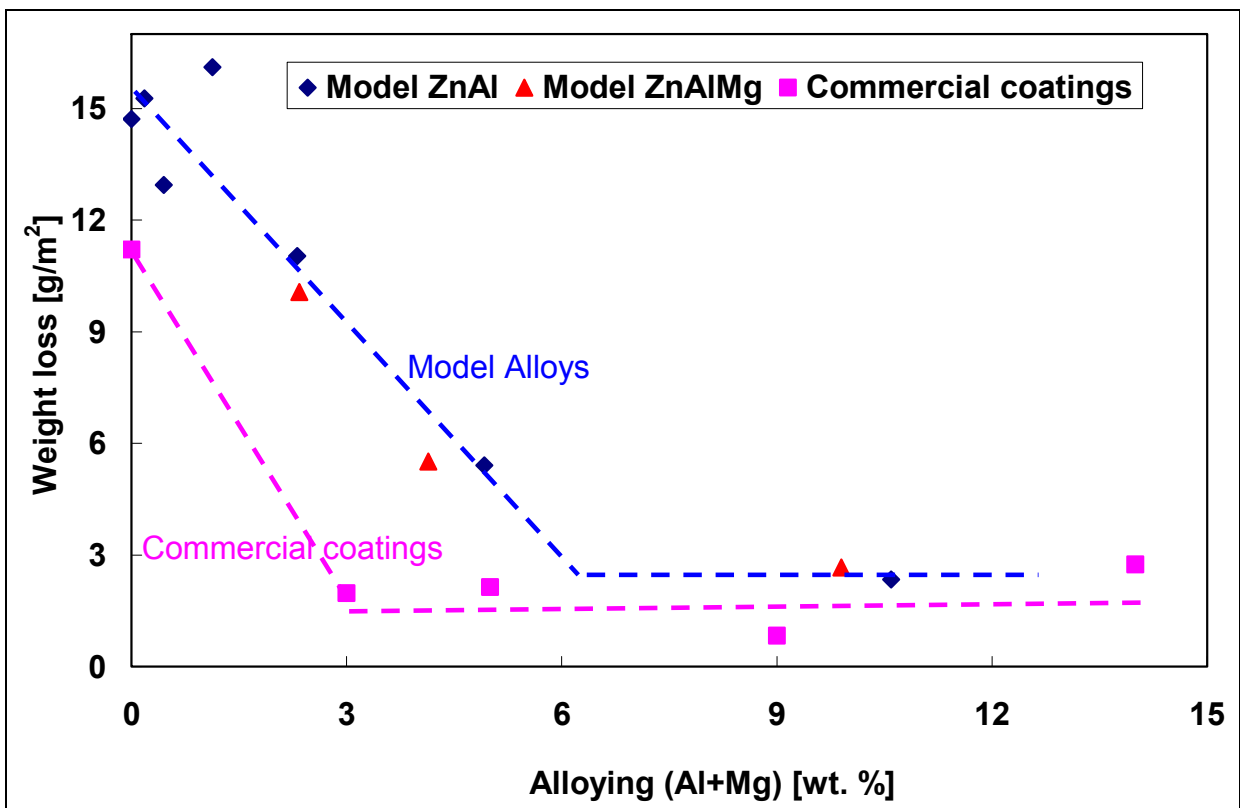
Figure 46 Weight loss versus alloying from 0 to 14%; comparison of metallic coatings and model alloys after 4 weeks of exposure at 20°C and 80 % RH at the chloride contamination of 1400 mg/m²

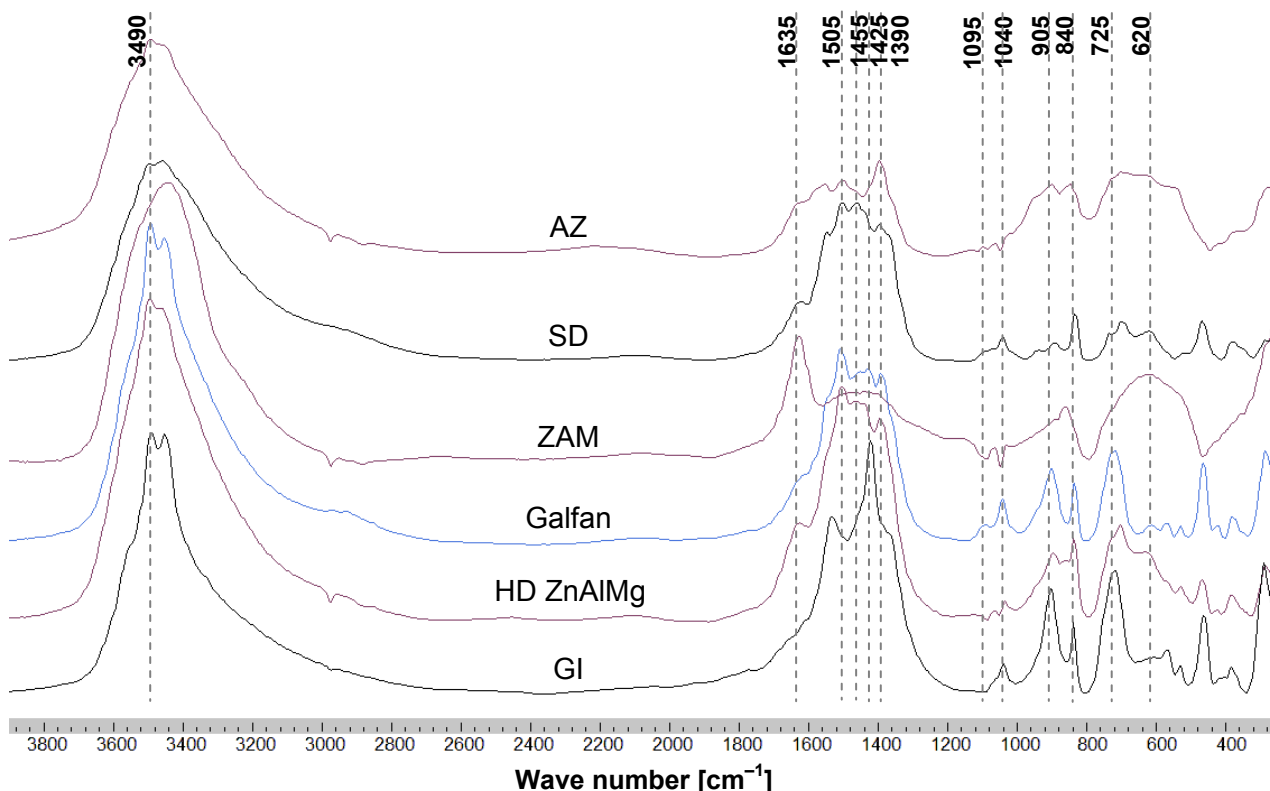
Figure 47 Infrared transmission spectra of corrosion products collected on coated materials with deposited sodium chloride at the chloride concentration of 1400 mg/m² exposed for 28 days at 20°C and at 80 % RH

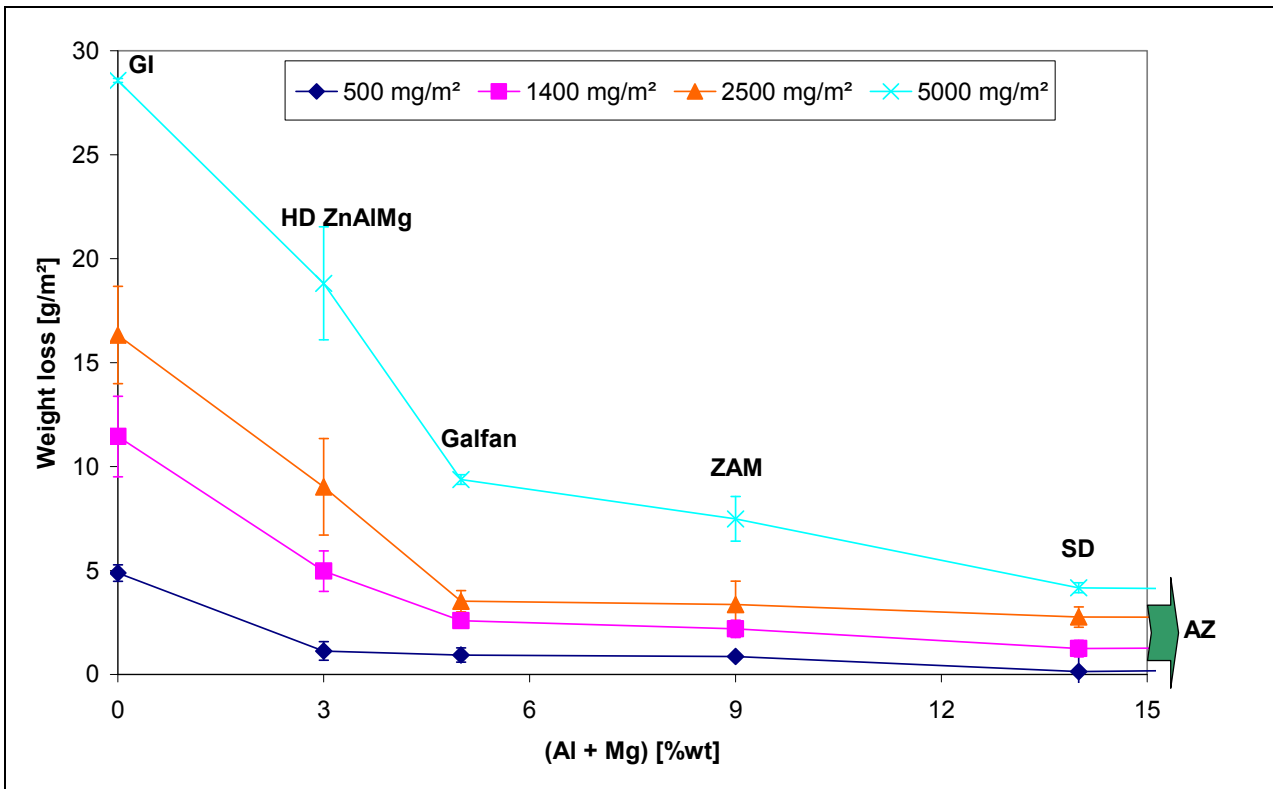
Figure 52 Weight loss vs. alloying for metallic coated steel after 4 weeks of exposure at 40°C and 80 % RH

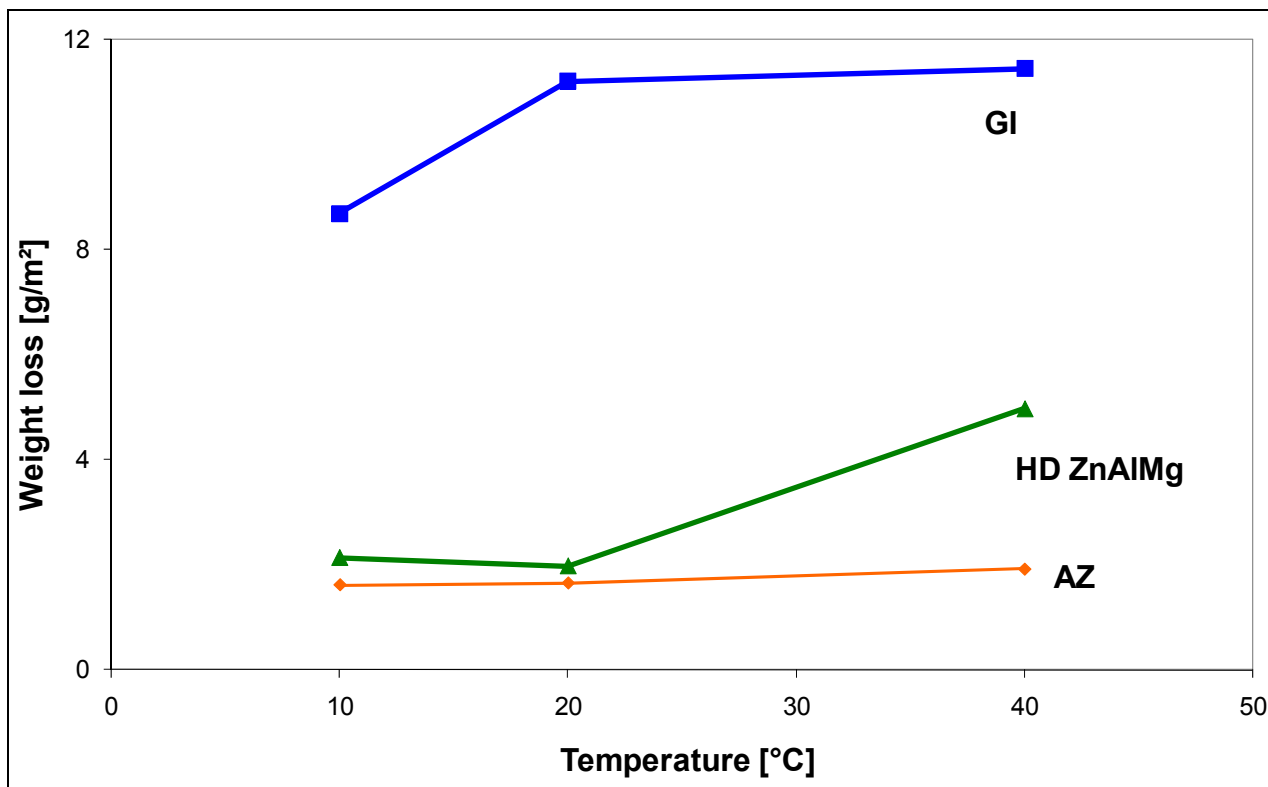
Figure 54 Weight loss dependence of GI, HD ZnAlMg and AZ on temperature at 80 % RH after 4 weeks of exposure of samples contaminated by 1400 mg/m² of chloride

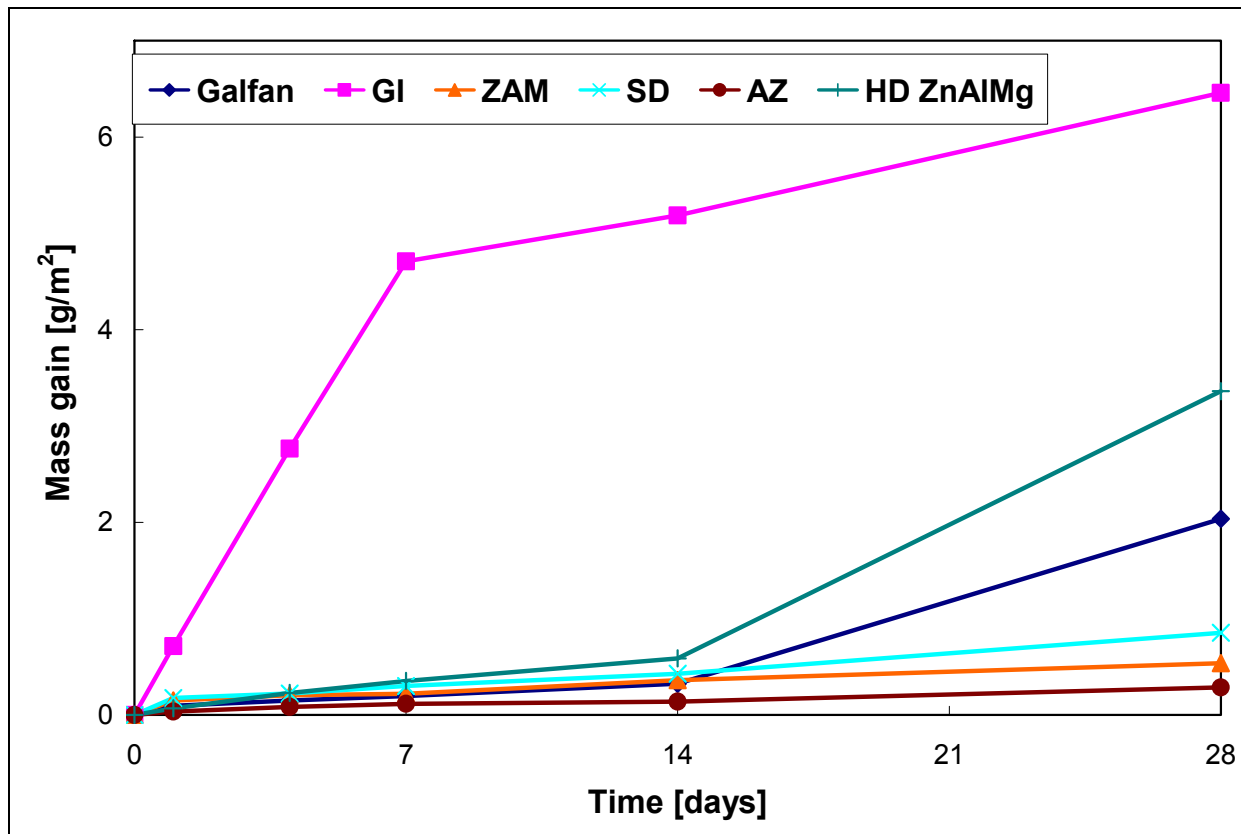
Figure 55 Wet mass gain of metallic coated steel sheets during exposure at 20°C and 65 % RH with 1400 mg/m² chloride

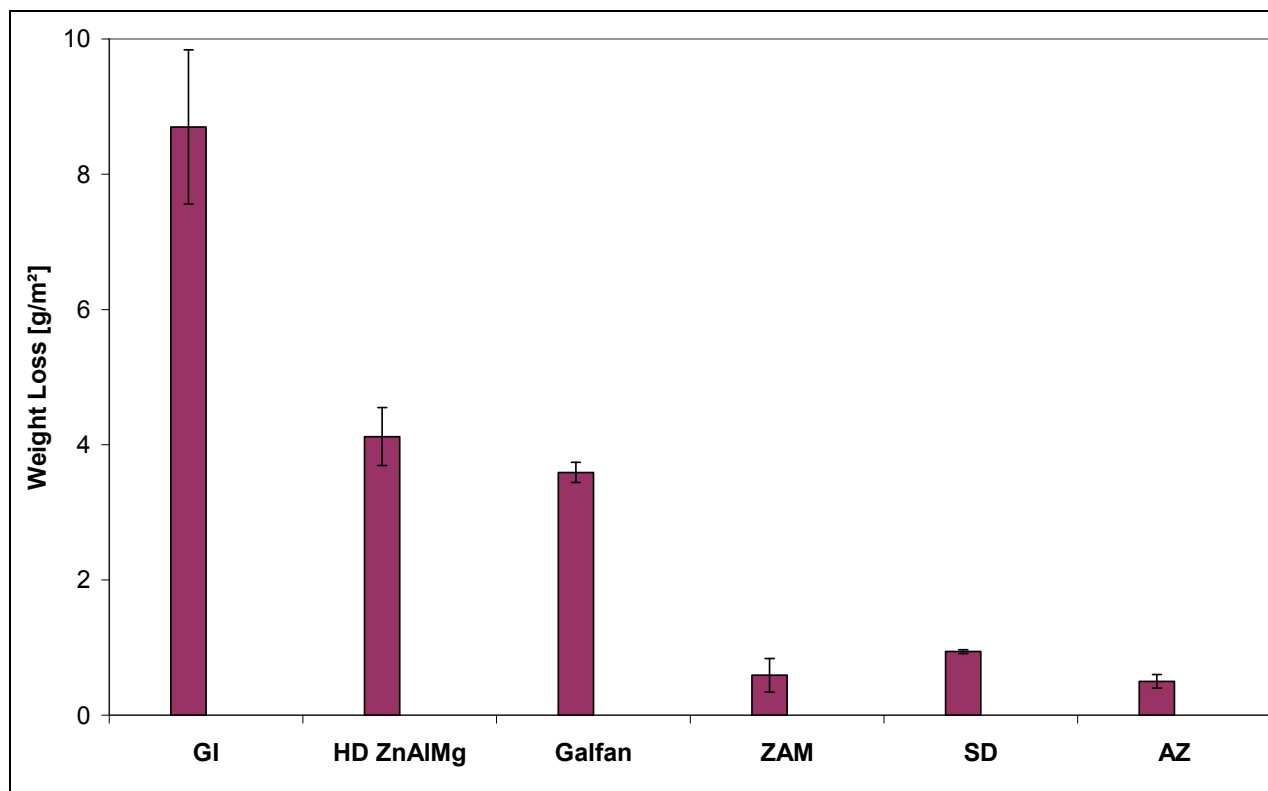
Figure 59 Weight loss of coated steel panels after 4 weeks of exposure at 20°C and 65 % RH at chloride contamination of 1400 mg/m²

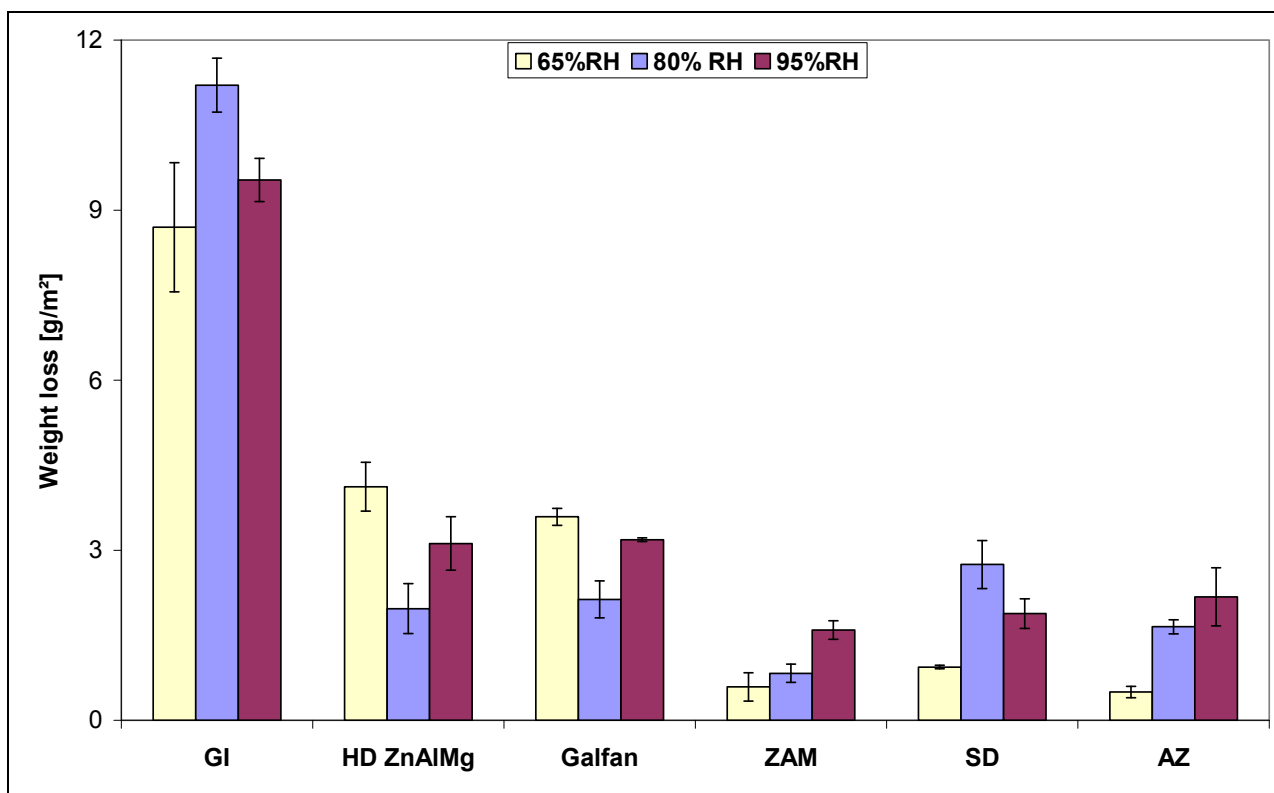
Figure 61 Weight loss comparison at 65, 80 and 95 % RH at 20°C after 4 weeks of exposure of metallic coatings contaminated with 1400 mg/m² chloride

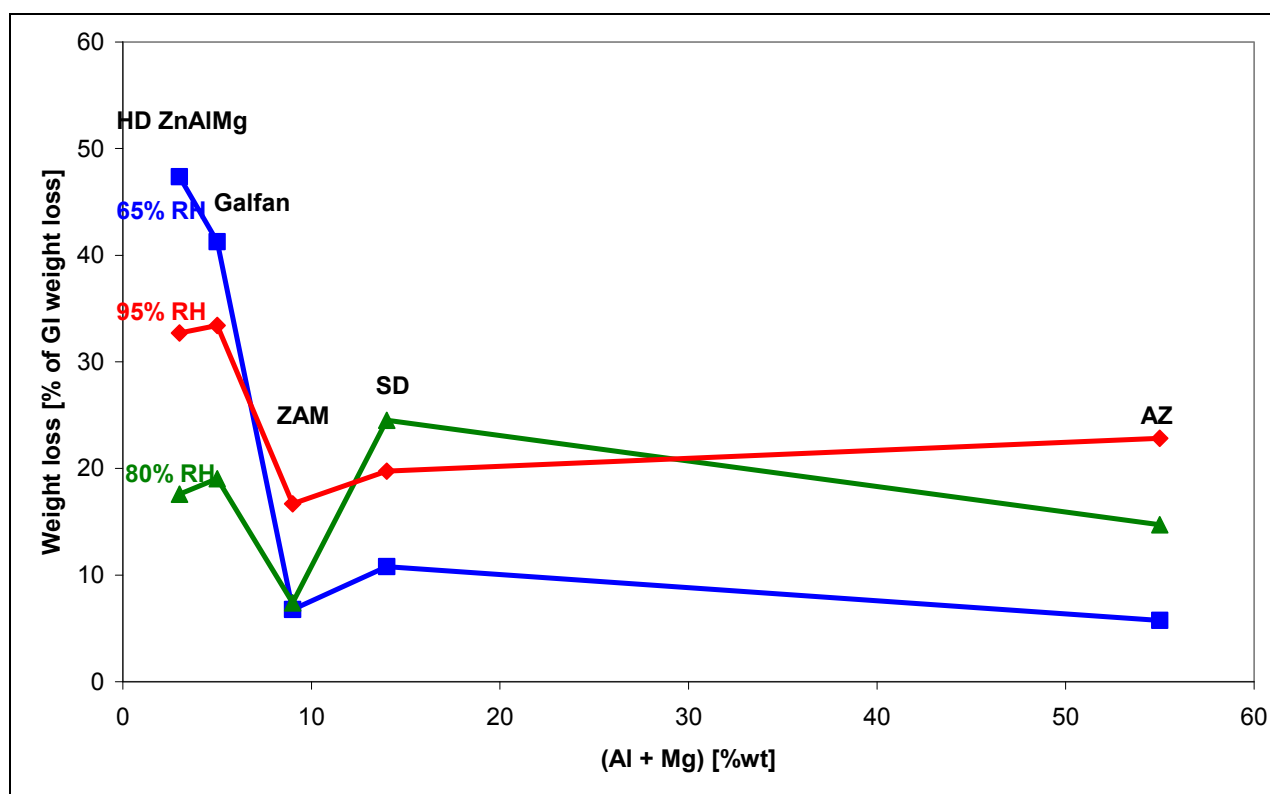
Figure 62 Relative weight loss to GI versus alloying, comparison between 65, 80 and 95 % RH at 20°C, after 4 weeks of exposure for a chloride contamination of 1400 mg/m²

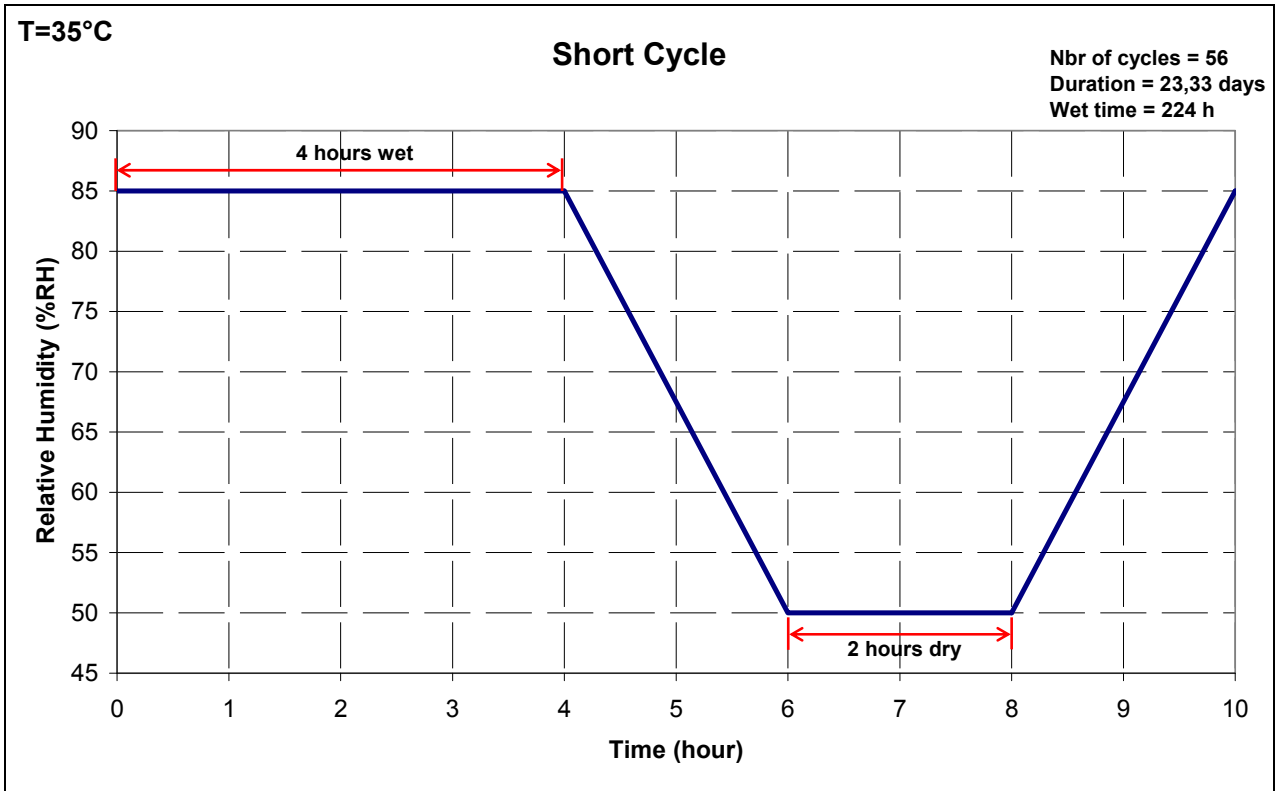
Figure 63 Wet (80 % RH) / dry (50 % RH) short cycle

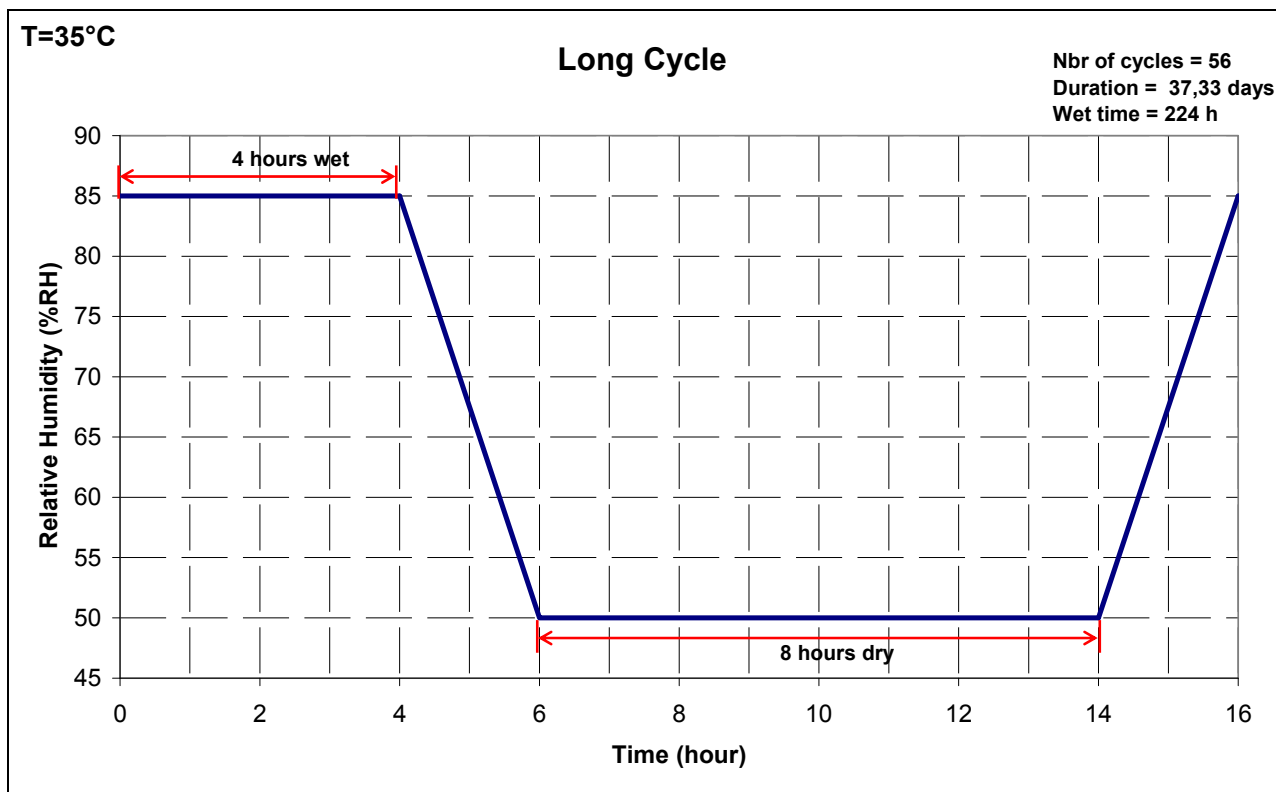
Figure 65 Wet (80 % RH) / dry (50 % RH) long cycle

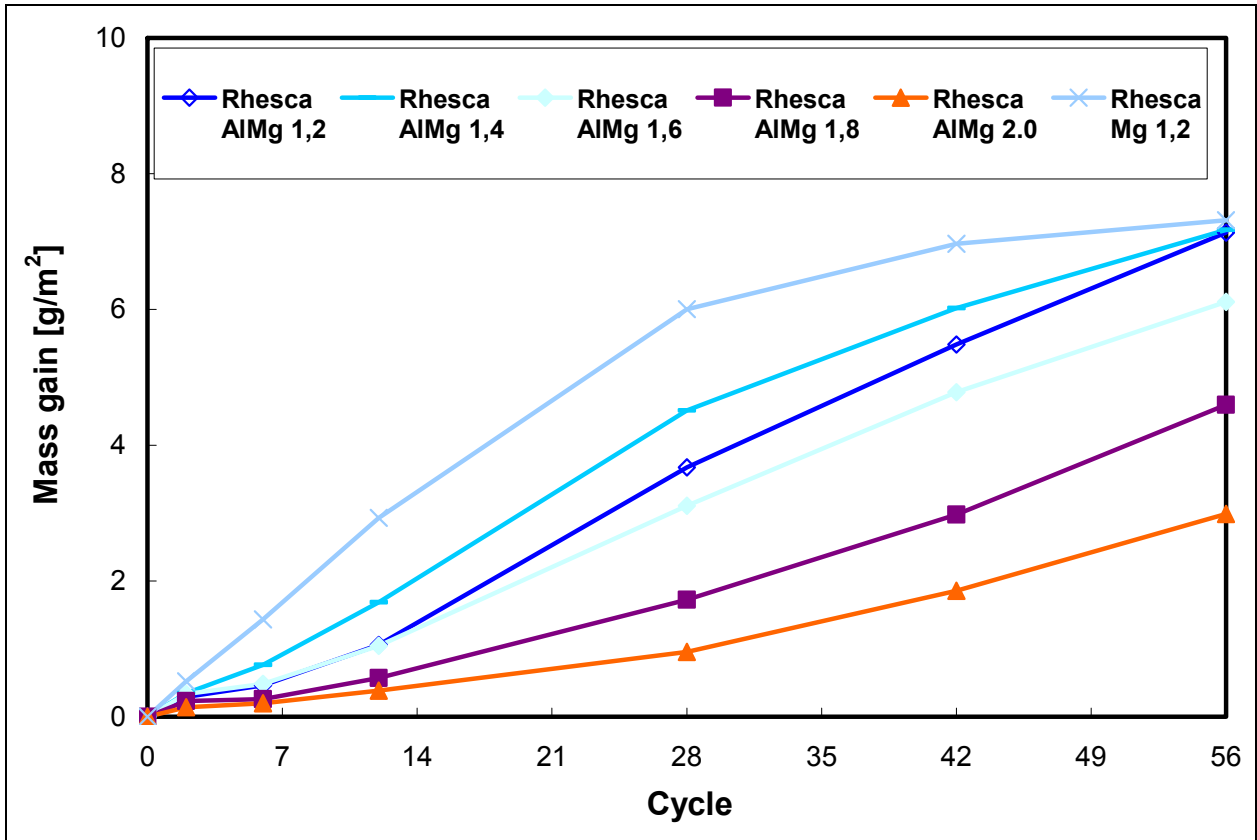
Figure 66 Wet mass gain of Rhesca coated steel panels during exposure in basic cycle

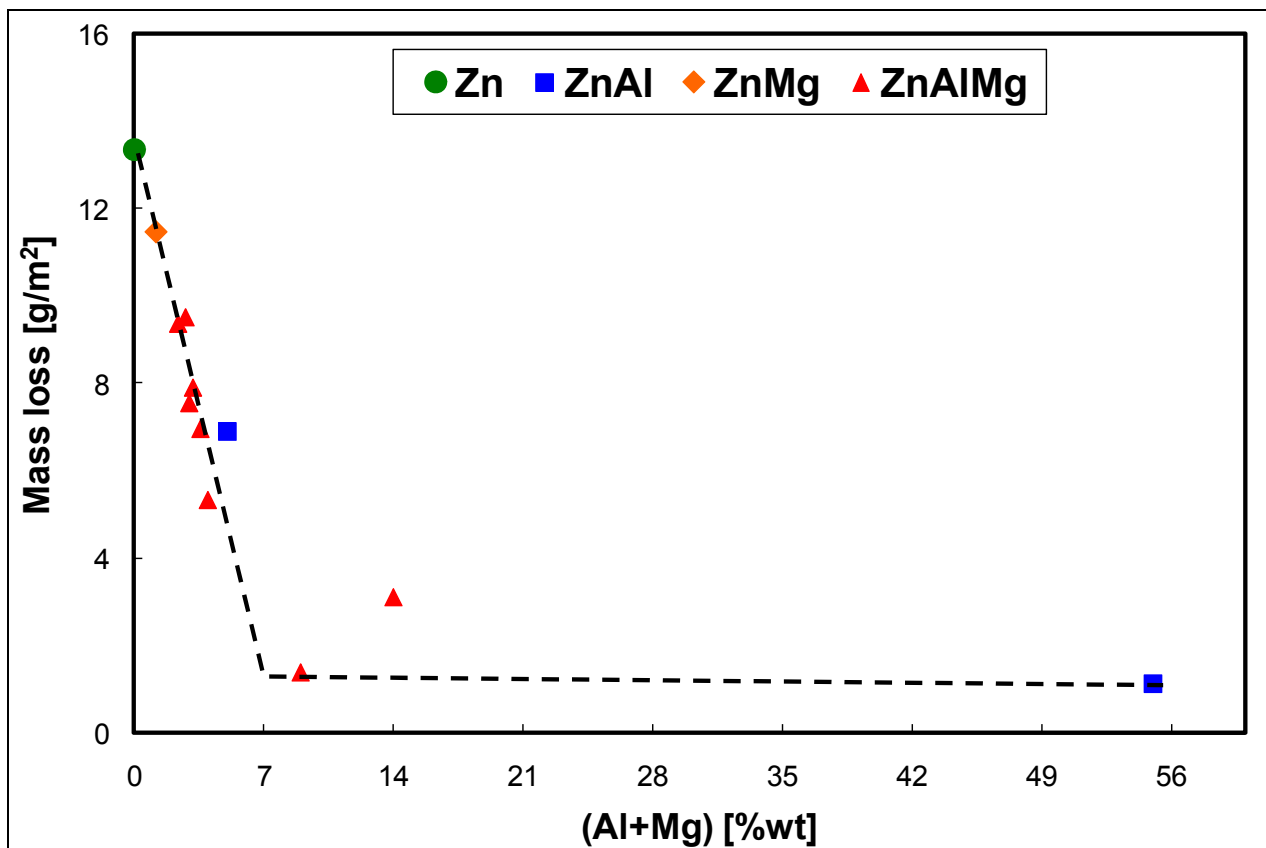
Figure 72 Average weight loss of metallic coated panels exposed in 3 test cycles at 35°C versus alloying; Zn: GI, ZnAl: Galfan, AZ; ZnMg: Rhesca Mg 1.2, ZnAlMg: Other coatings

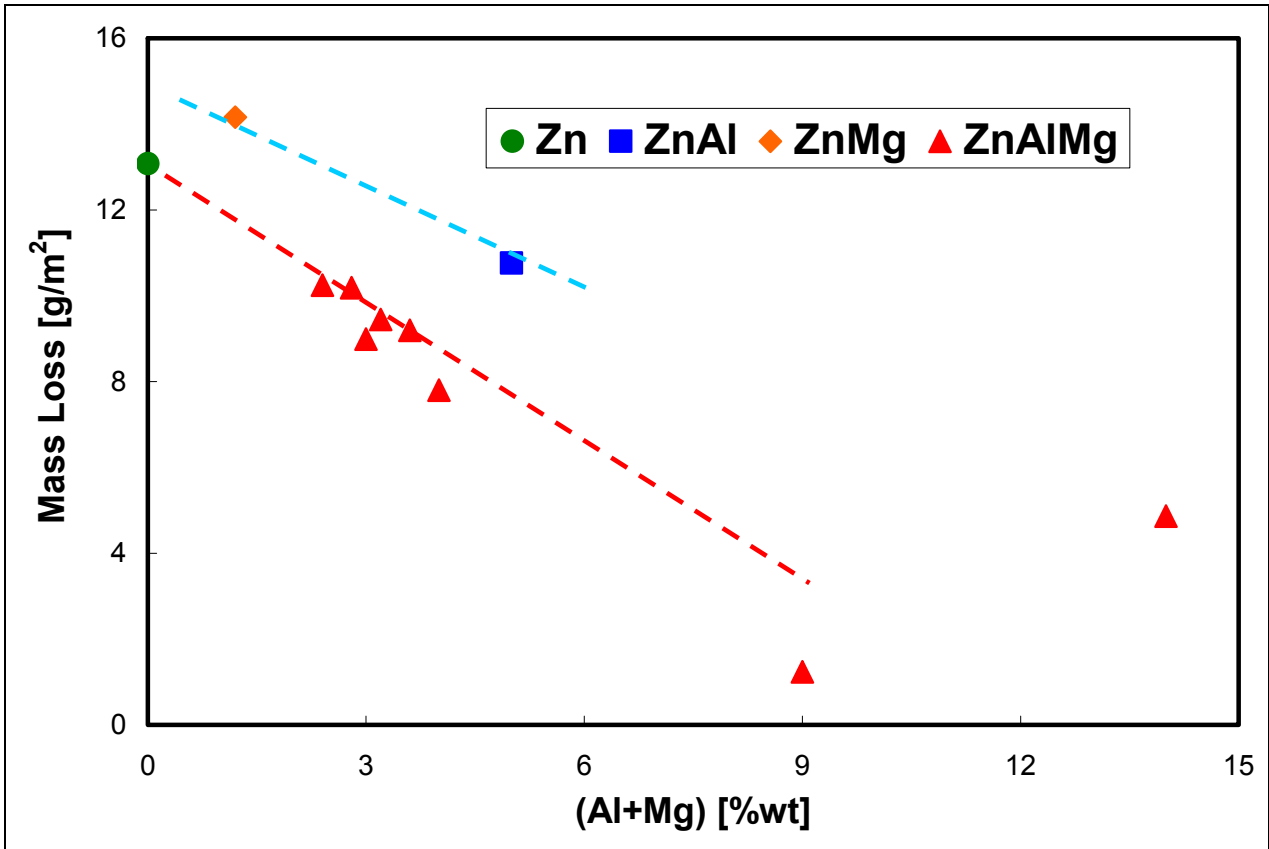
Figure 73 Weight loss of metallic coated panels versus alloying in the short cycle; Zn: GI, ZnAl: Galfan, AZ; ZnMg: Rhesca Mg 1.2, ZnAlMg: Other coatings

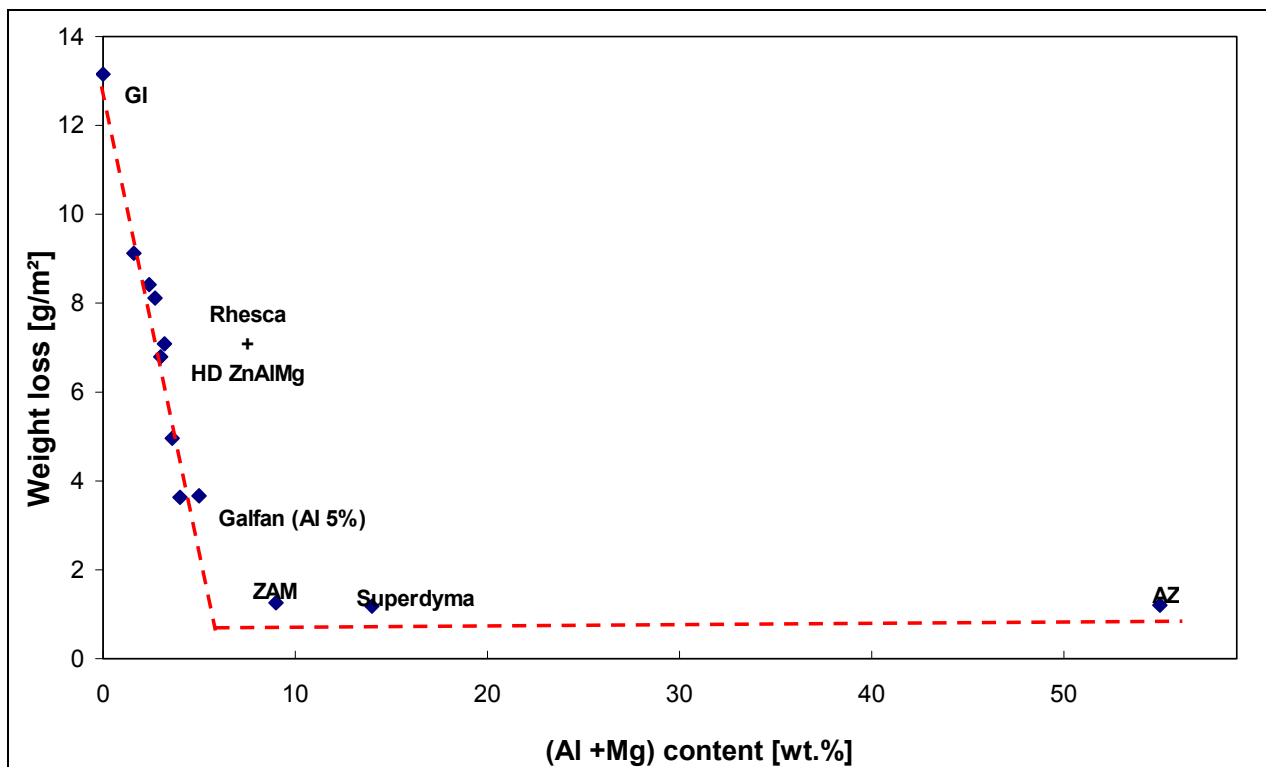
Figure 75 Weight loss vs. alloying from 0 to 55 wt. % for metallic coated panels exposed in the basic test

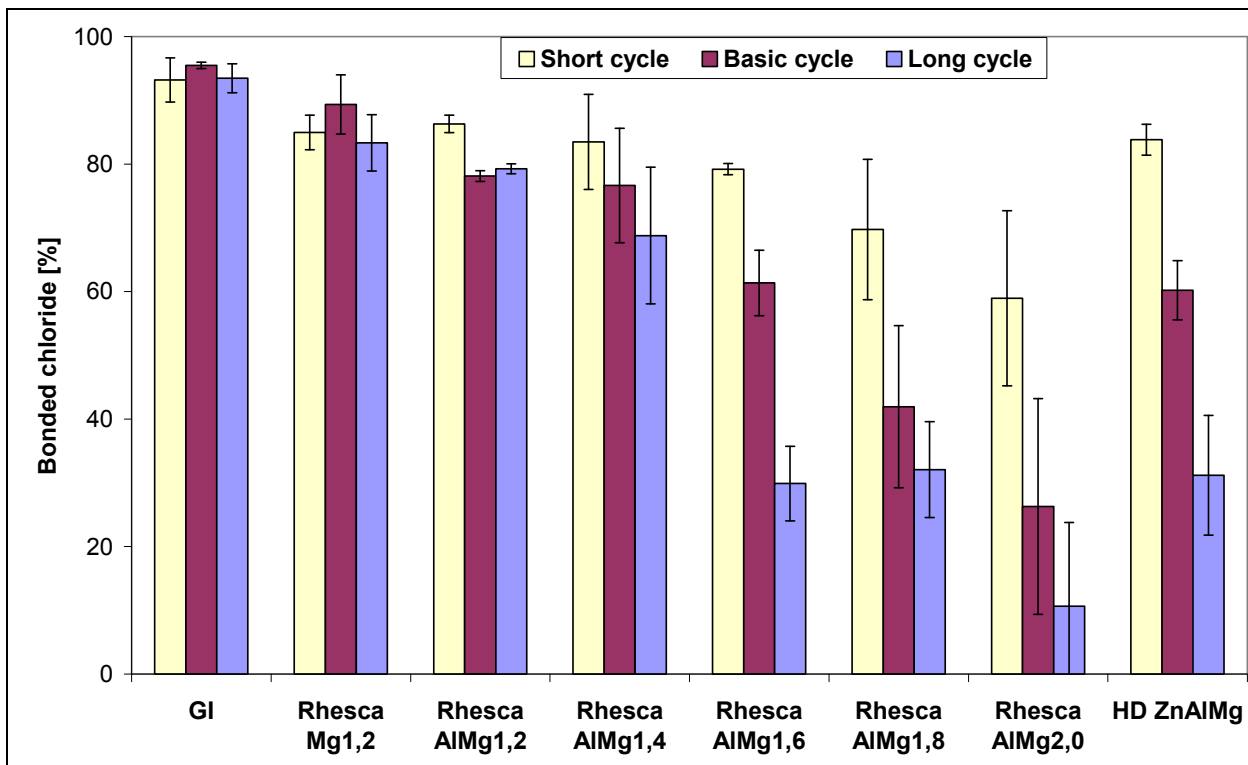
Figure 76 Bonded chloride on the surface from ion chromatography of water extract of corrosion products; results for coated panels exposed in three cyclic tests contaminated with 1400 mg/m^2 of chloride
