Zn-Mg Automotive Steel Coatings

Final Report

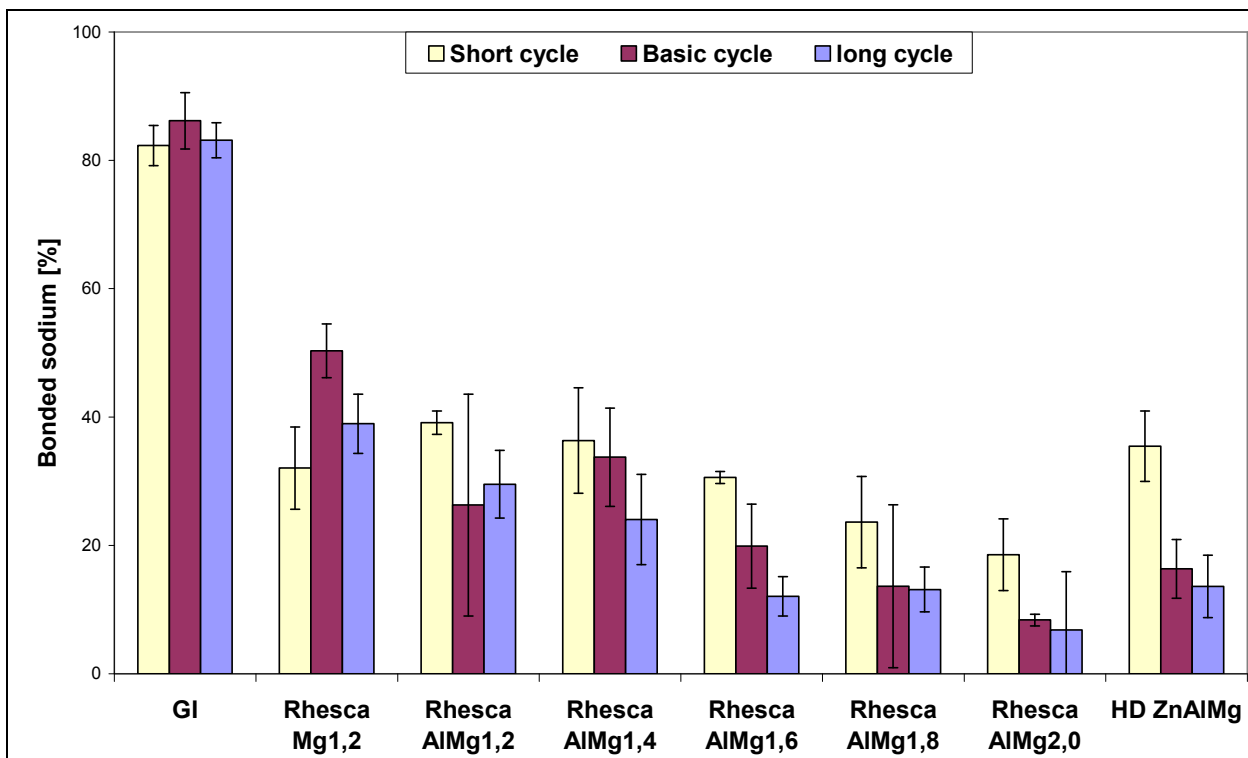
Figure 77 Bonded sodium on the surface from ion chromatography of water extract of corrosion products; results for coated panels exposed in three cyclic tests and contaminated with 1400 mg/m^2 of chloride and 907 mg/m^2 of sodium

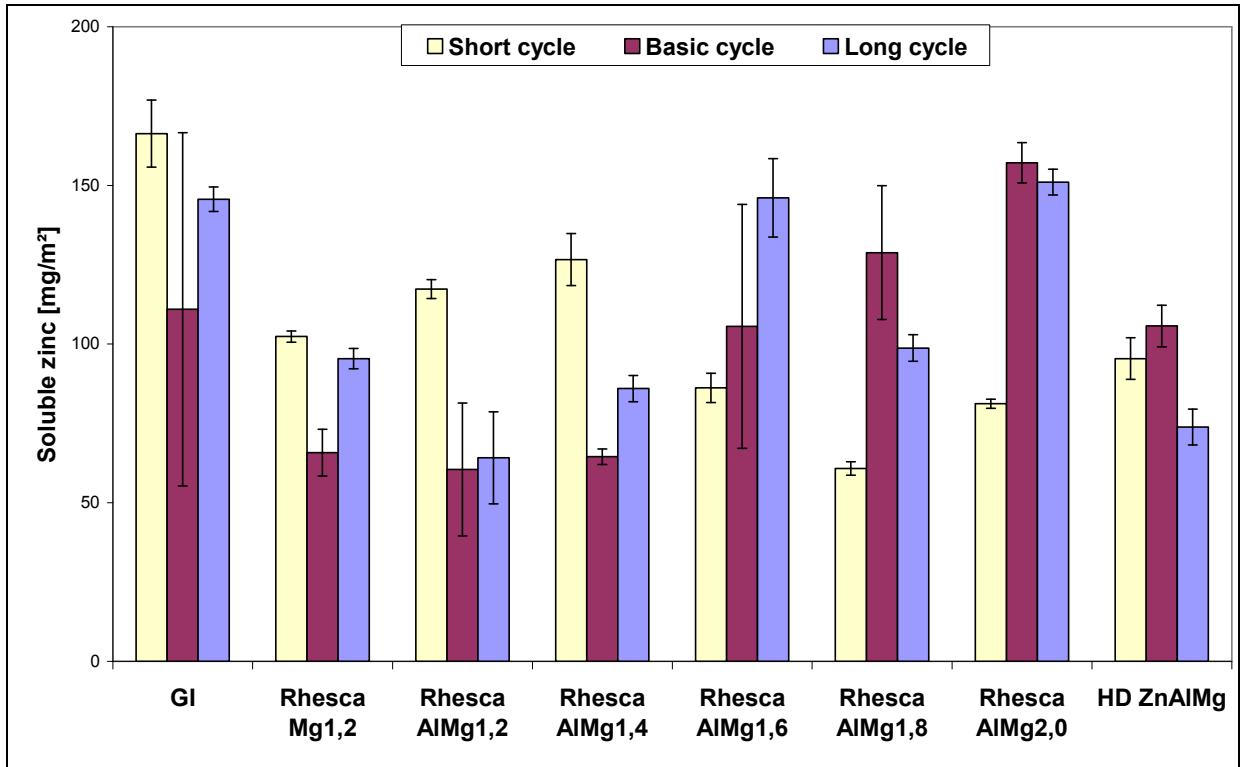
Figure 78 Soluble zinc on the surfaces, from ion chromatography of water extract of corrosion products; results for coated panels exposed in three cyclic tests and contaminated with 1400 mg/m² of chloride and 907 mg/m² of sodium

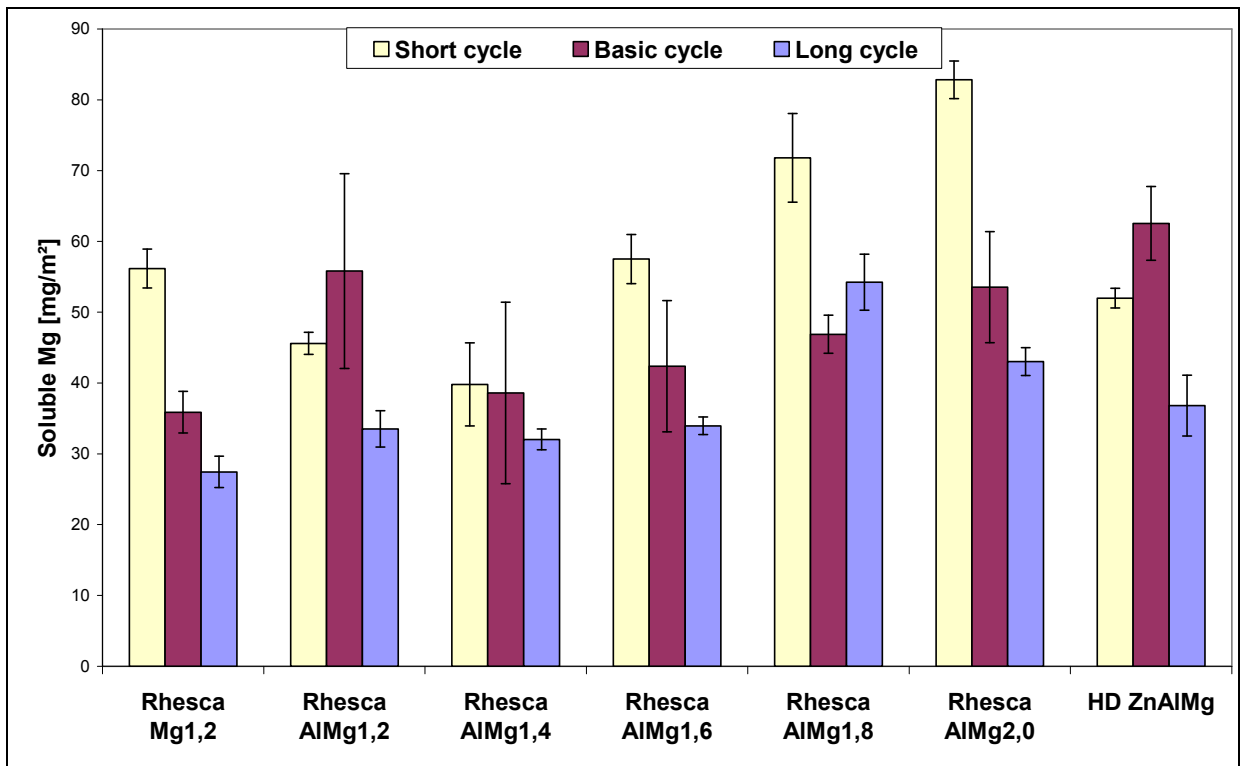
Figure 79 Soluble magnesium on the surfaces, from ion chromatography of water extract of corrosion products; results for coated panels exposed in three cyclic tests and contaminated with 1400 mg/m² of chloride and 907 mg/m² of sodium

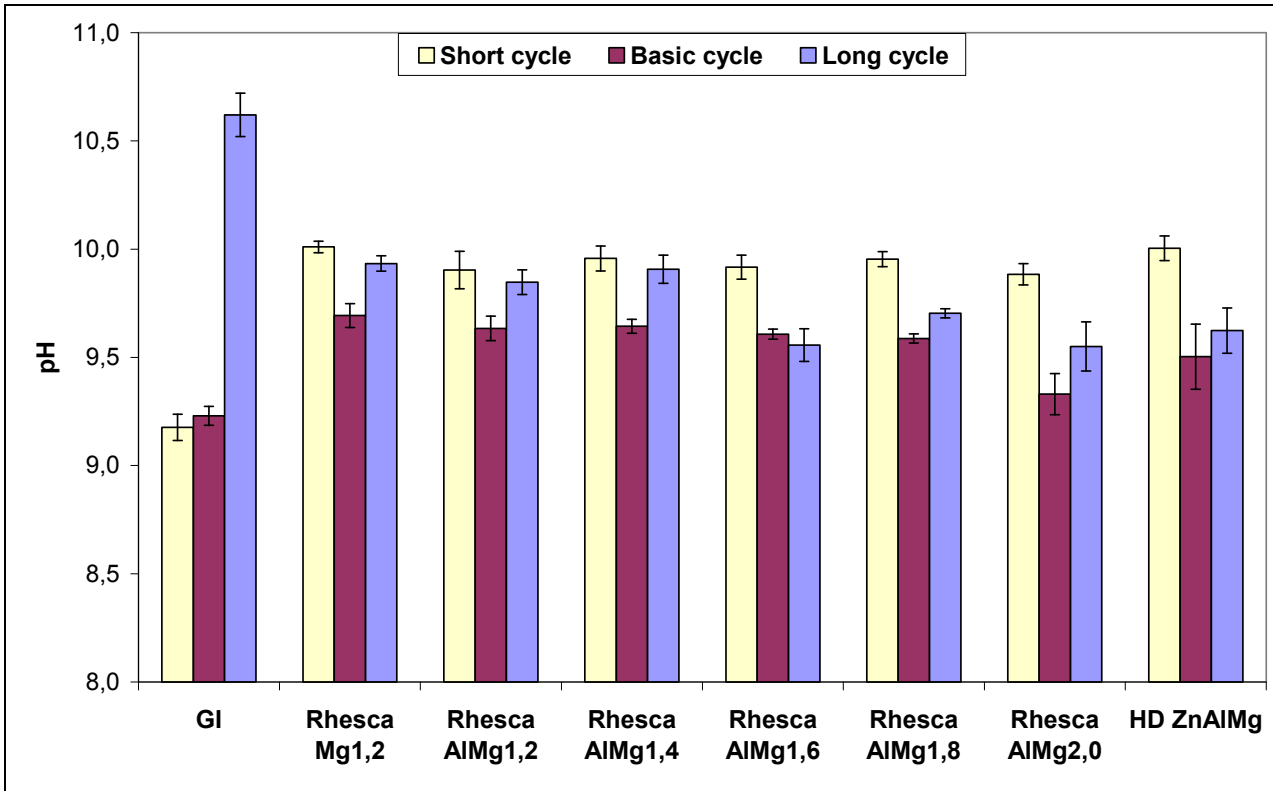
Figure 80 pH of water extracts obtained by dissolving corrosion products after cyclic tests

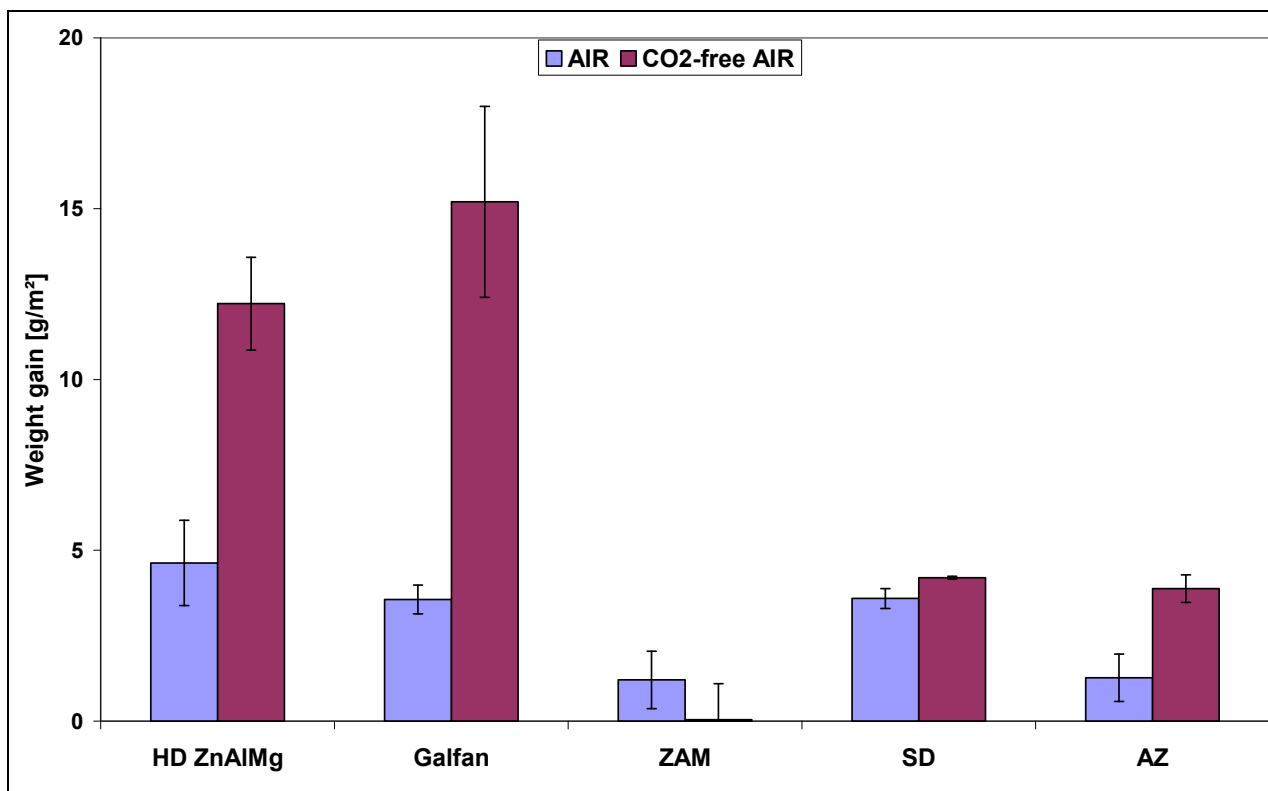
Figure 83 Weight gain after drying of metallic coated panels after 4 weeks of exposure in humid ambient and CO₂-free air at 20°C

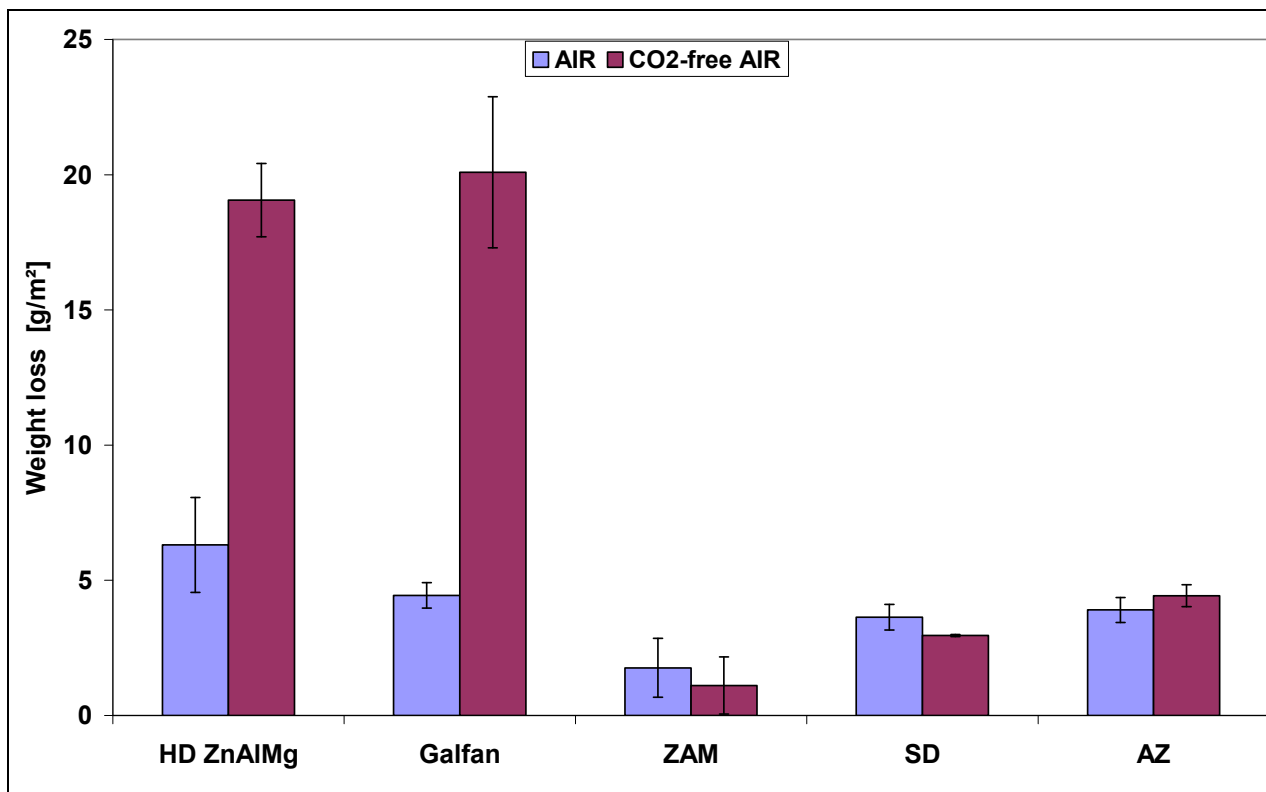
Figure 84 Weight loss of metallic coated panels after 4 weeks of exposure in humid ambient and CO₂-free air at 20°C

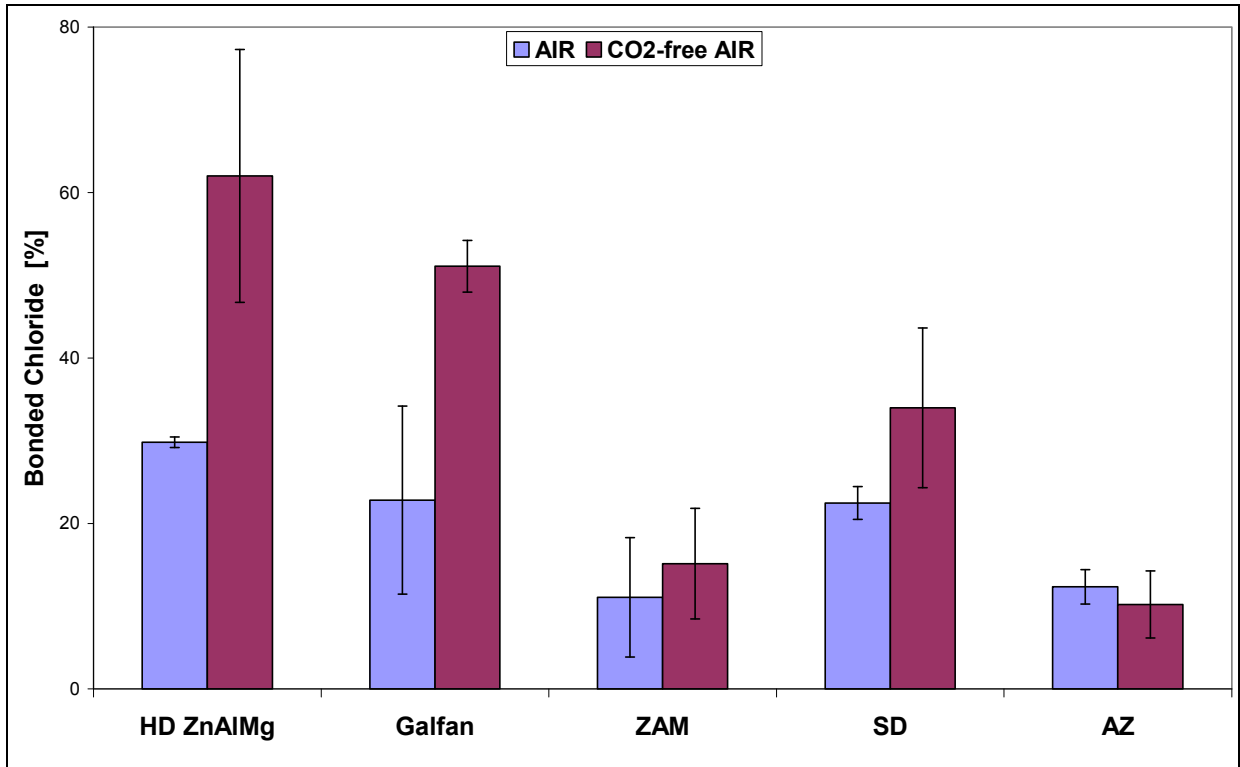
Figure 86 Bonded chloride from ion chromatography of water extract of corrosion products; results for metallic coated panels contaminated with 1400 mg/m² of chloride and exposed 4 weeks in air and in CO₂-free air at 20°C and high RH

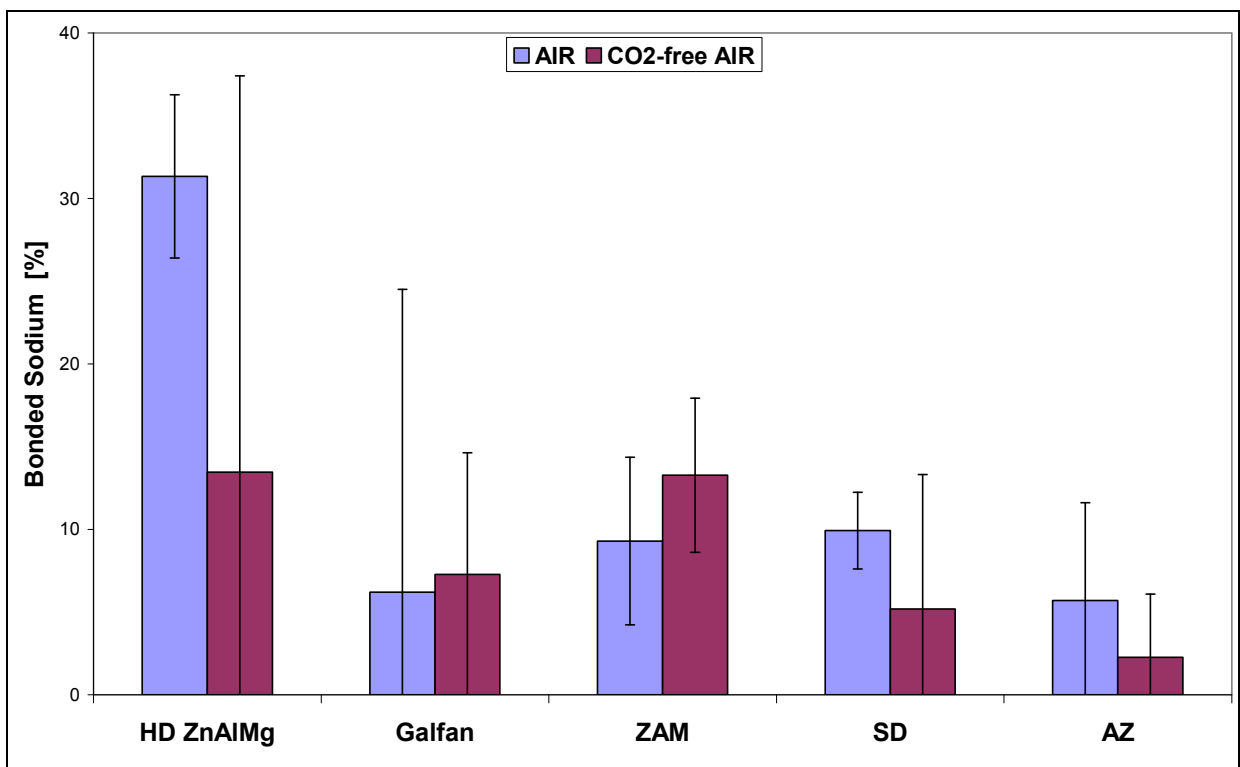
Figure 87 Bonded sodium from ion chromatography of water extract of corrosion products; results for metallic coated panels contaminated with 1400 mg/m² of chloride and 907 mg/m² of sodium and exposed for 4 weeks in air and in CO₂-free air at 20°C and high RH

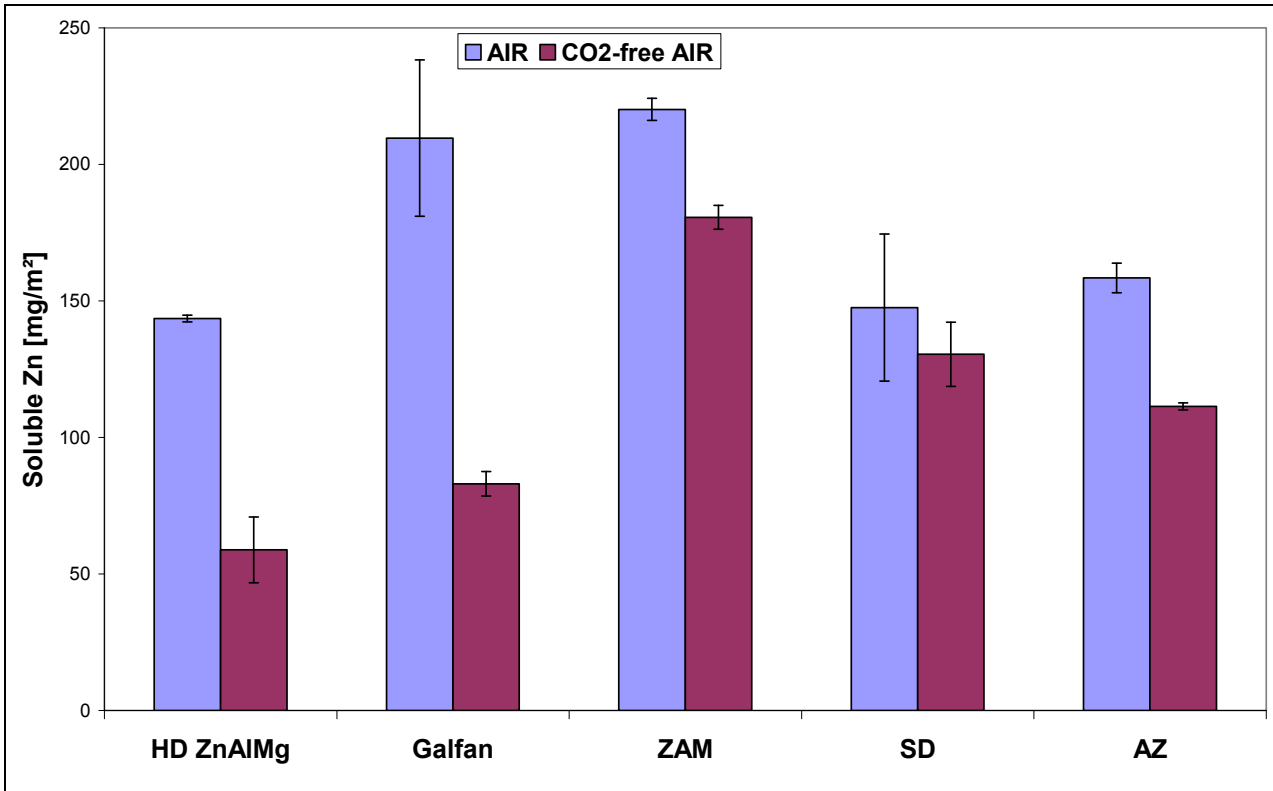
Figure 88 Soluble zinc on the surface from ion chromatography of water extract of corrosion products; results for metallic coated panels exposed in air and in CO₂-free air at 20°C and high RH

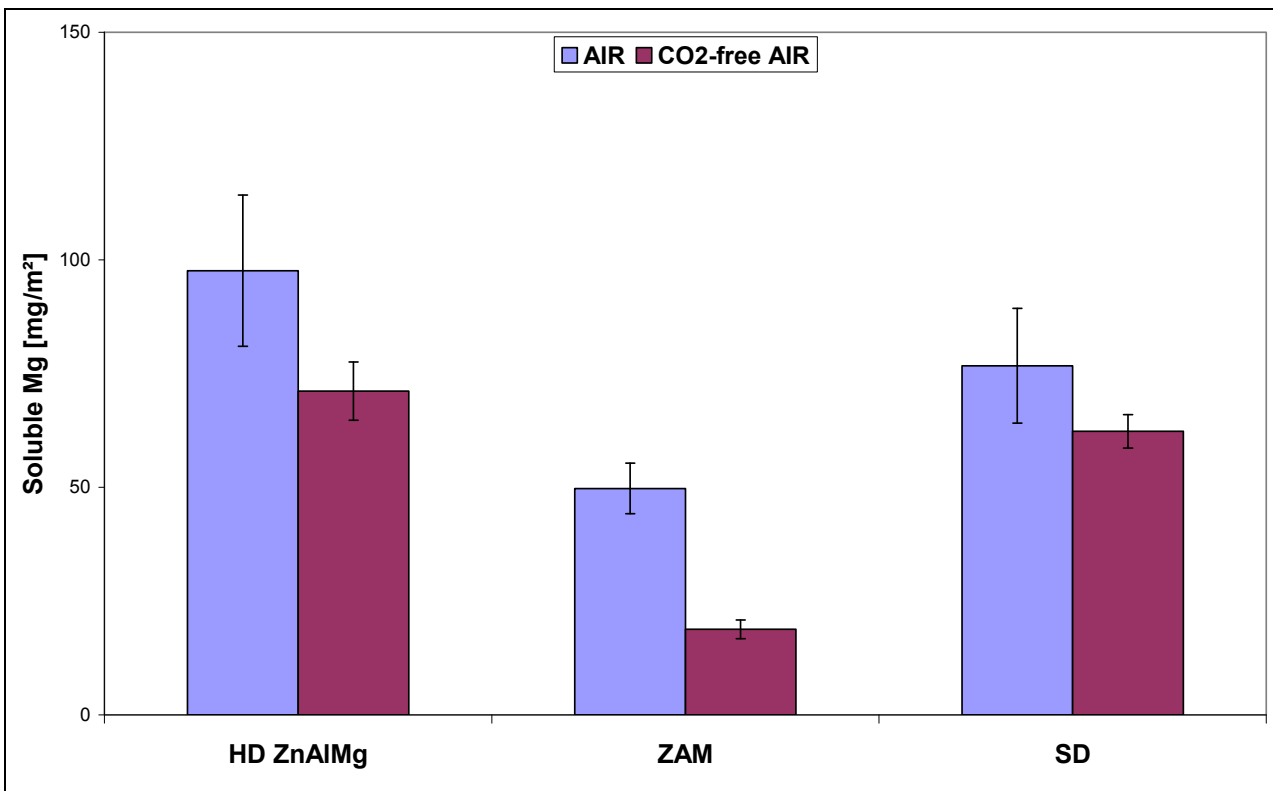
Figure 89 Soluble magnesium on the surface from ion chromatography of water extract of corrosion products; results for metallic coated panels exposed in air and in CO₂-free air at 20°C and high RH

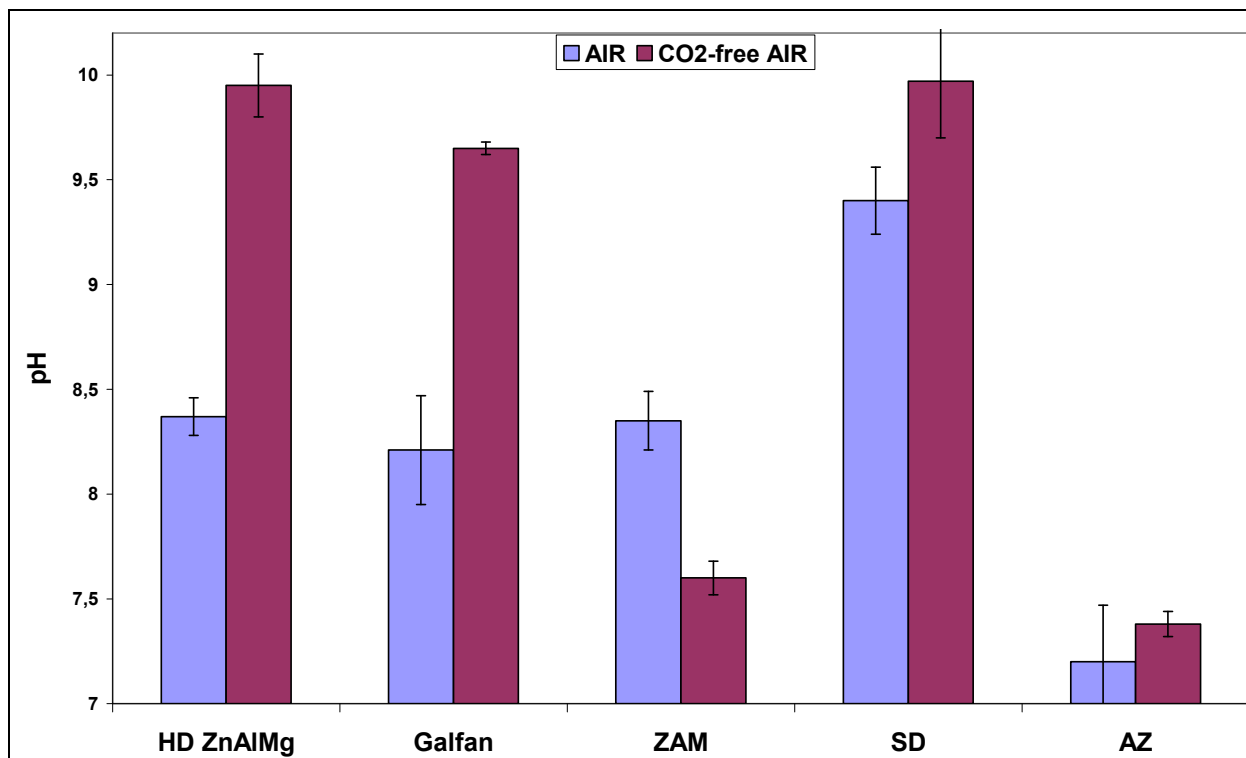
Figure 90 pH of water extracts obtained by dissolving the corrosion products after tests in air and in CO₂-free air at 20°C and high RH

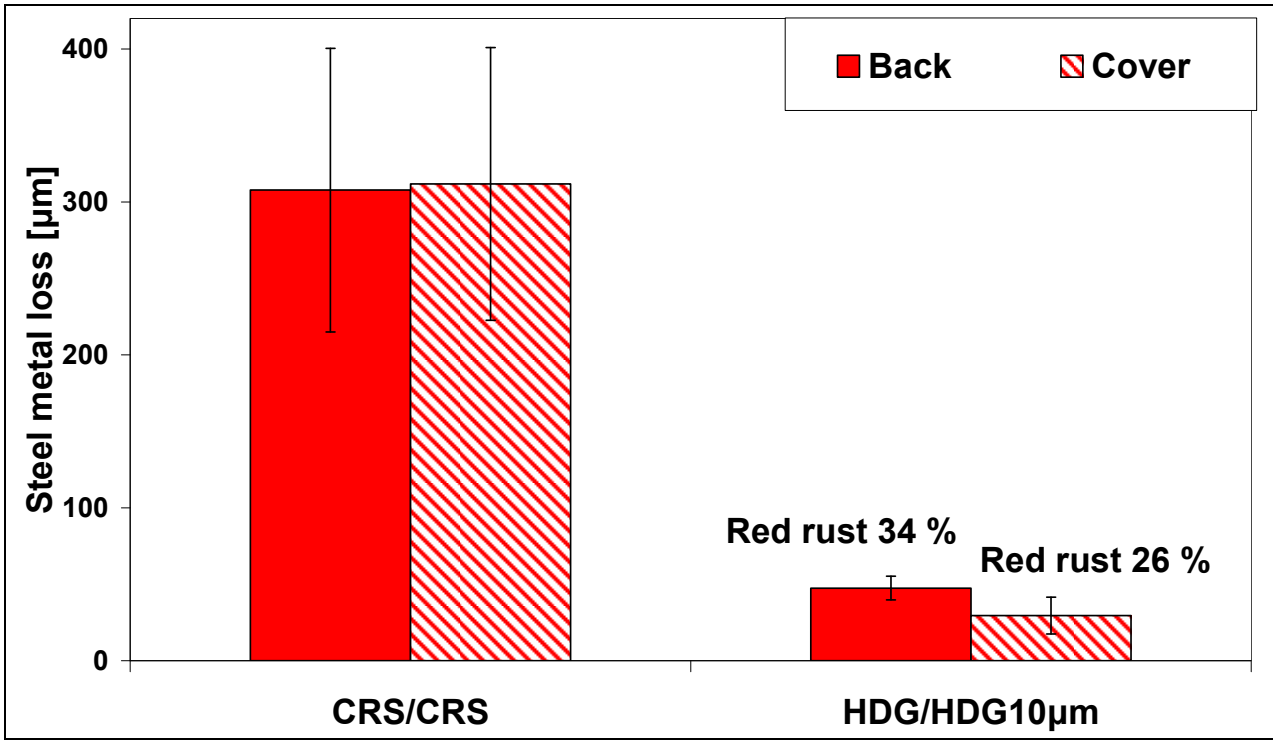
Figure 99 Corrosion of steel of Renault crevice panels made of CRS and GI at 10 µm with the extent of red rust in percentage (results for both the "cover" and the "back" parts of the Renault crevice configuration are showed)

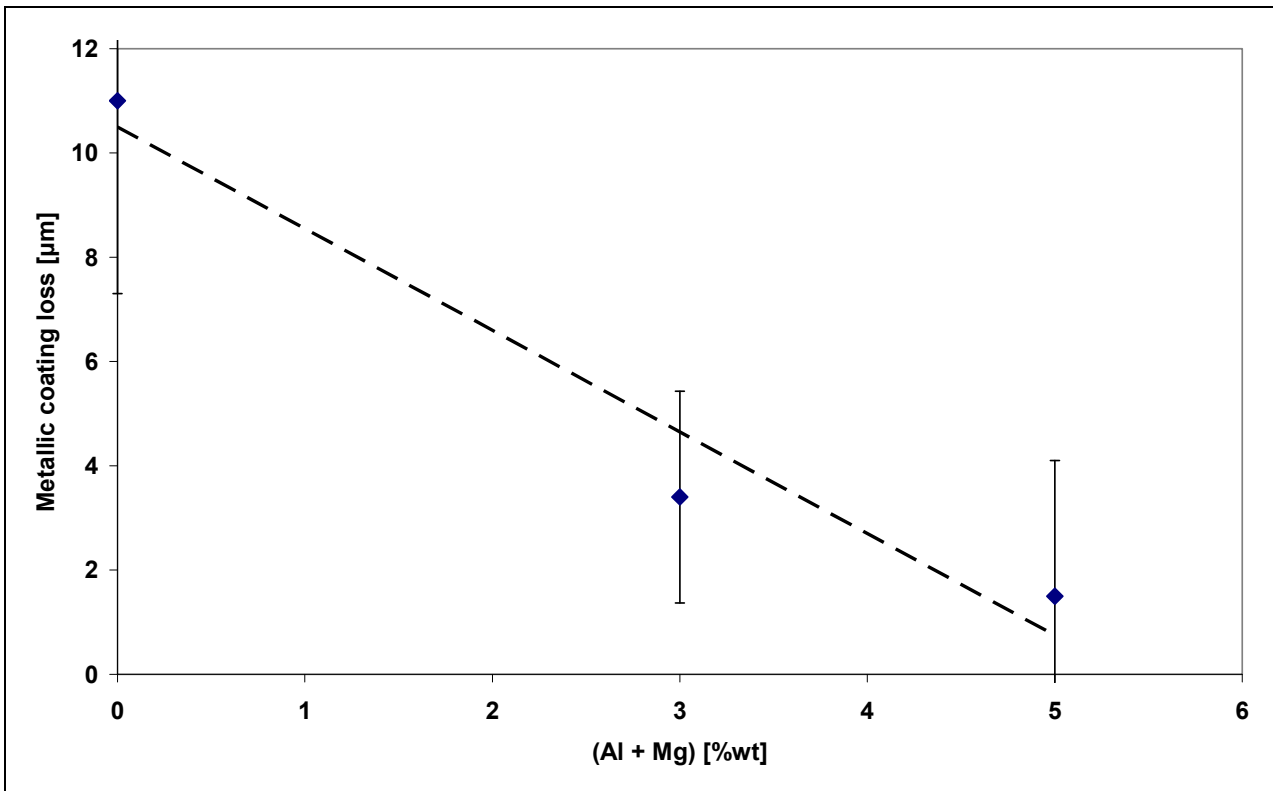
Figure 100 Metallic coating loss versus total alloying elements

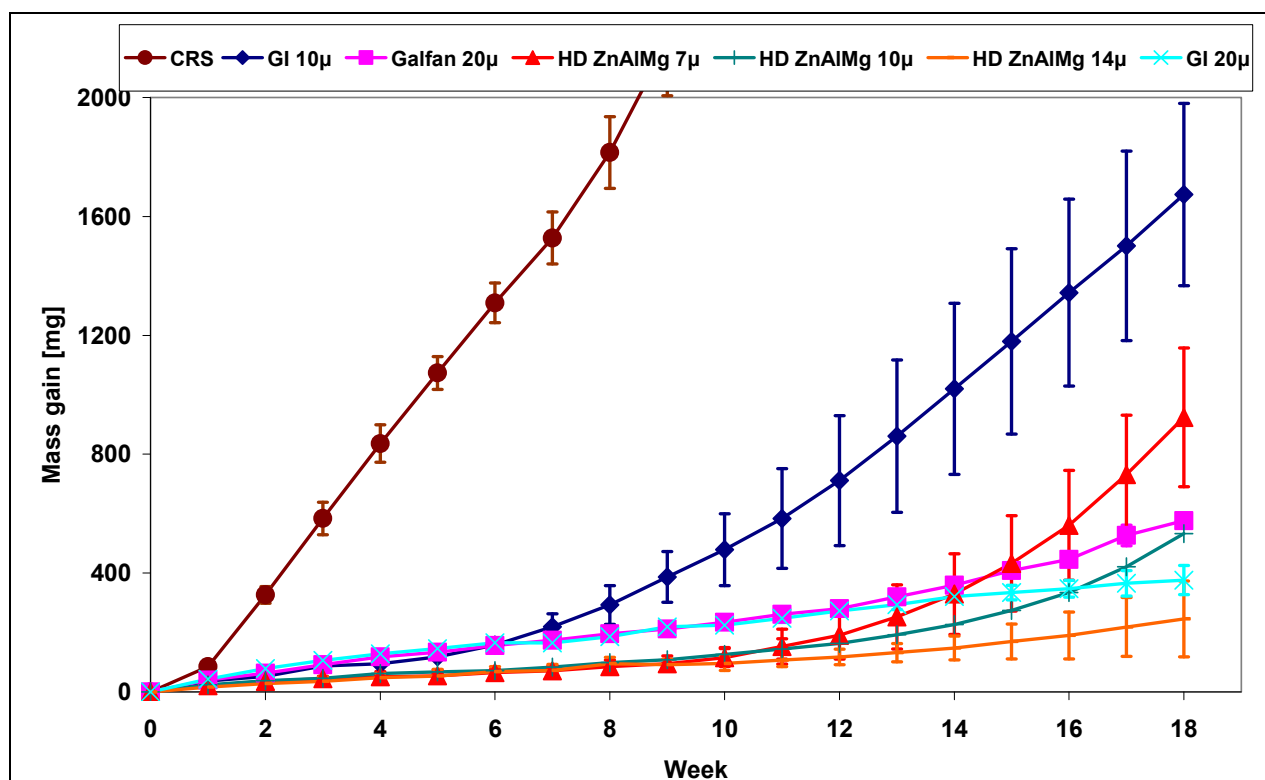
Figure 101 Weight gain of Volvo crevice panels exposed in ACT

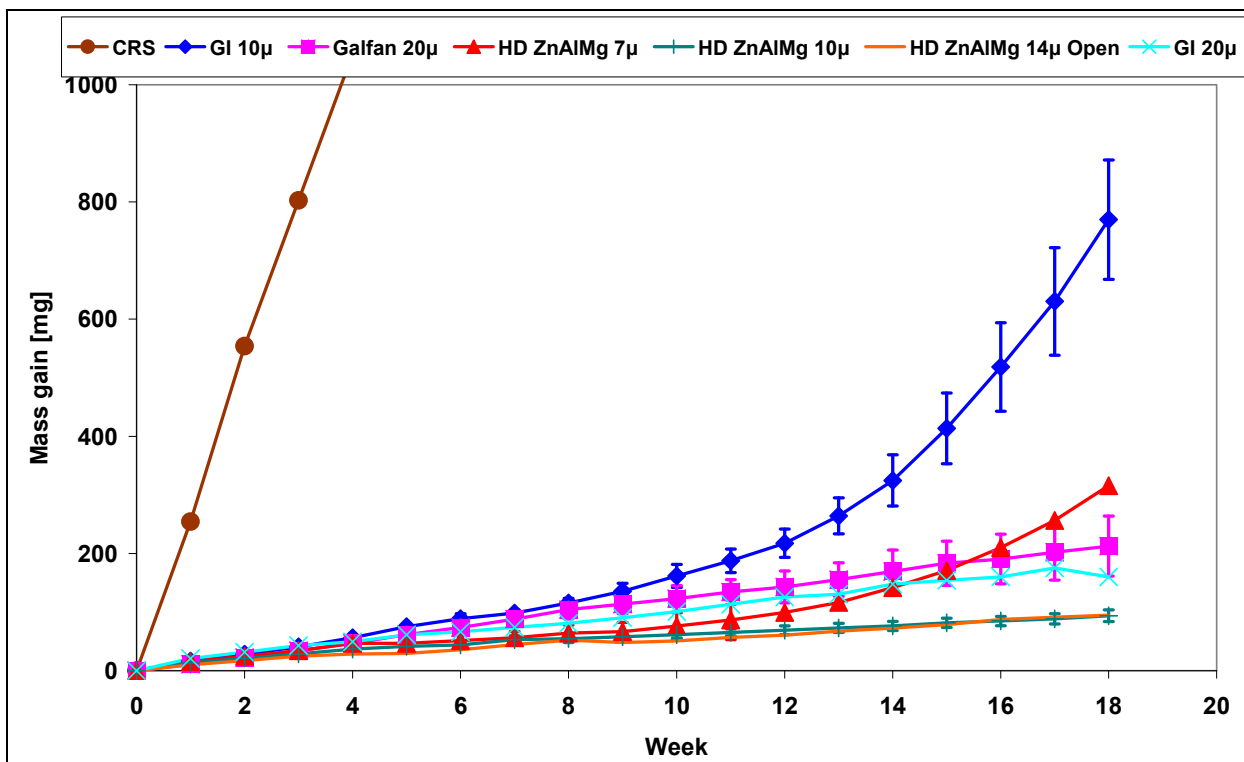
Figure 102 Weight gain of panels in open configuration exposed in ACT

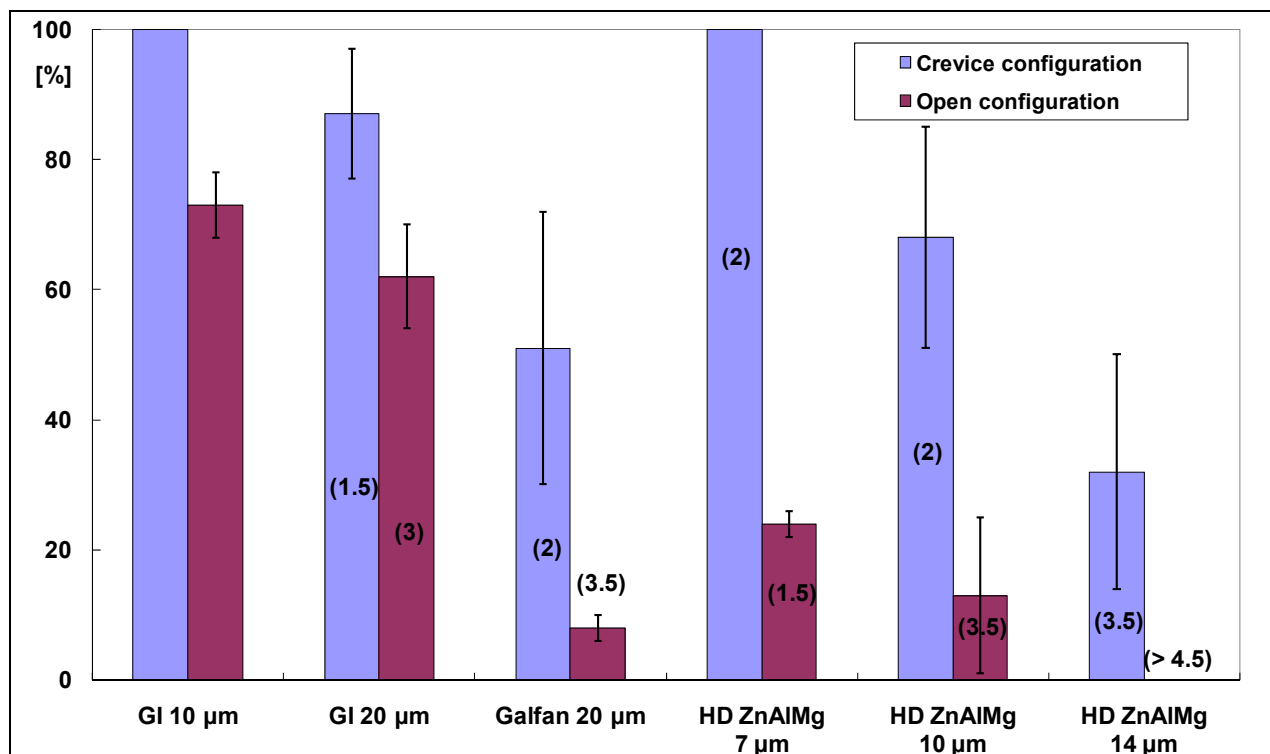
Figure 116 Summary of red rust spreading after 18 weeks of ACT for specimens in crevice and open configurations; delay of red rust appearance related to GI 10 μm is indicated in brackets

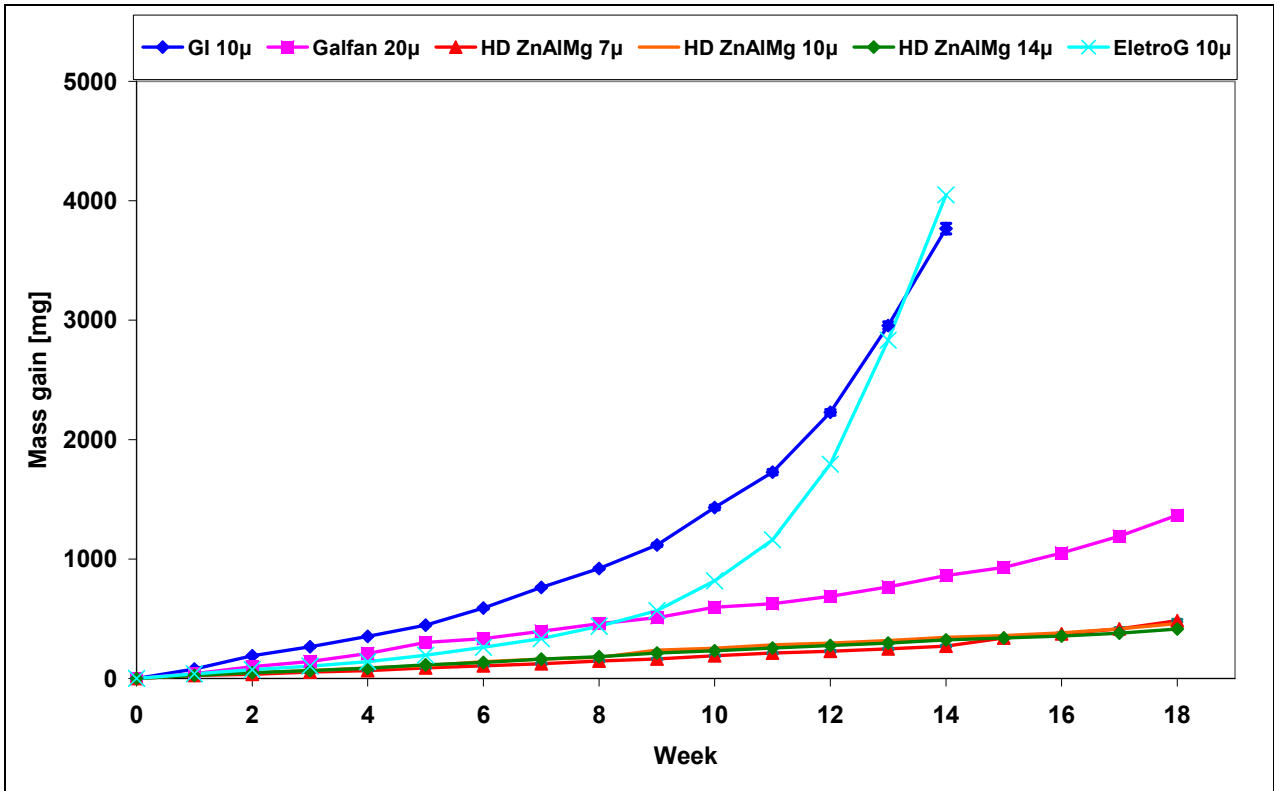
Figure 117 Weight gain of formed panels during accelerated ACT test

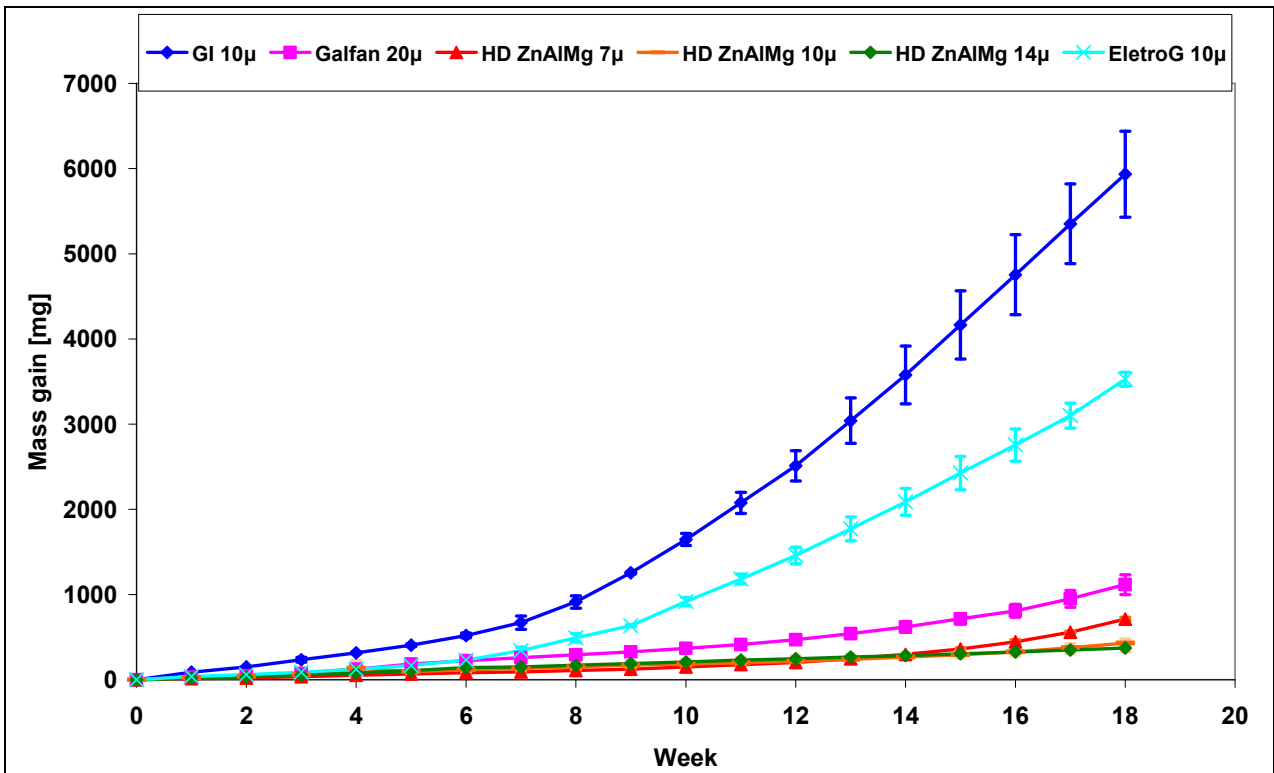
Figure 118 Weight gain of flat panels during accelerated ACT test

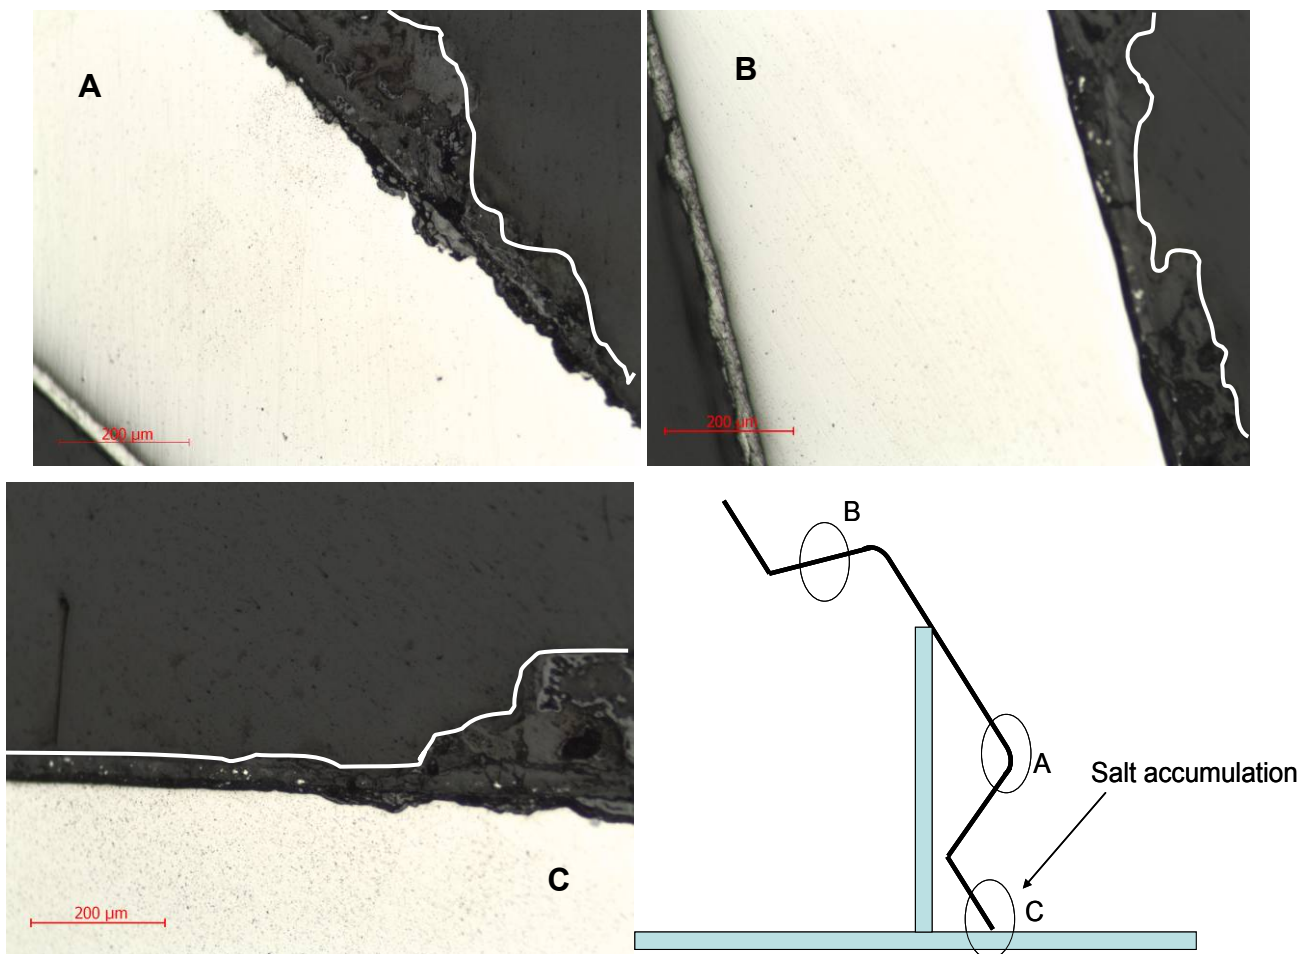
Figure 126 Microscopic observation of cross section of formed specimen of Galfan 20 µm after ACT; the boundary of the layer of corrosion products is shown with white line

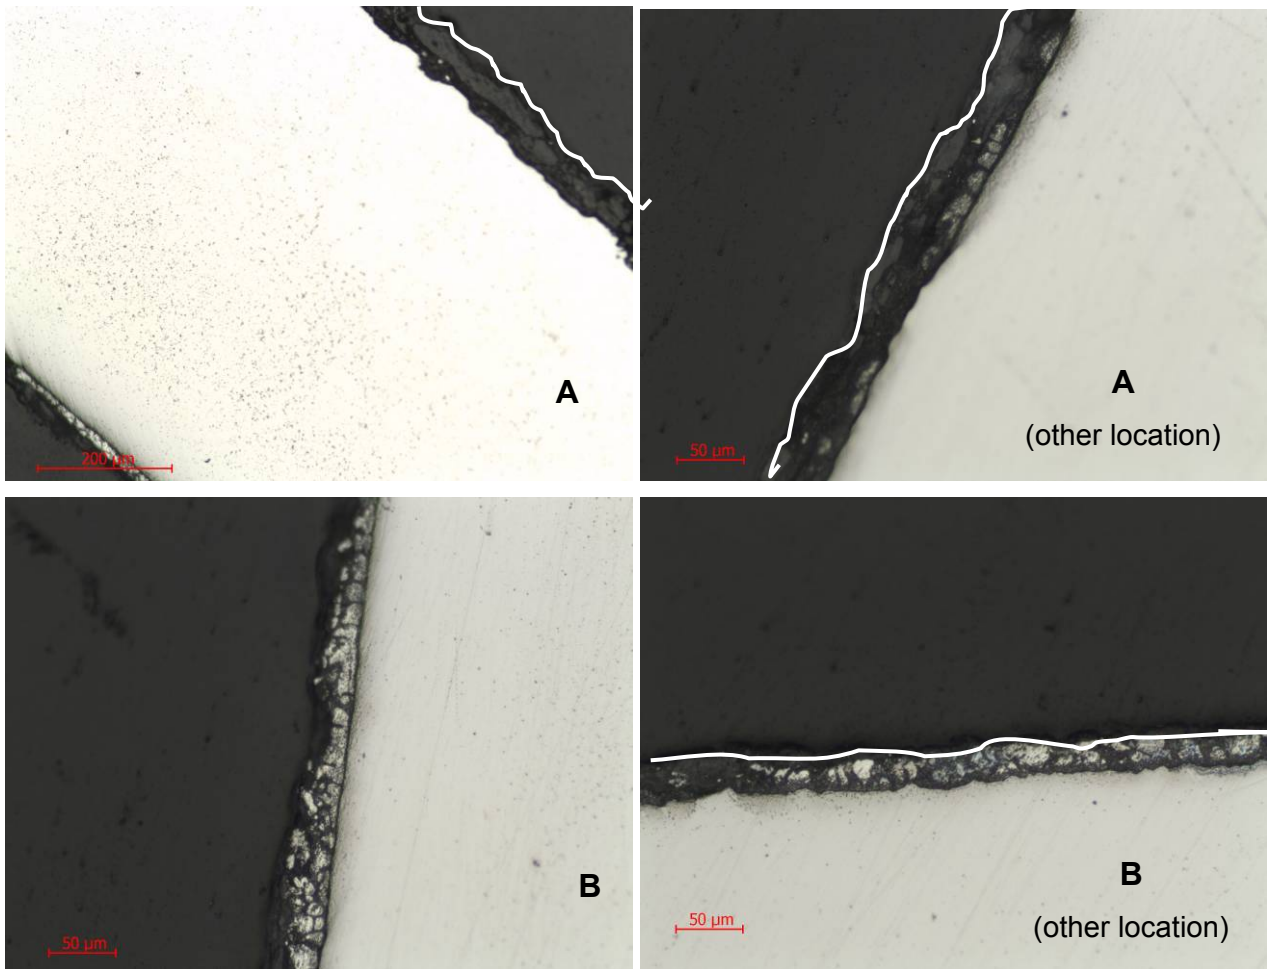
Figure 128 Microscopic observation of cross section of HD ZnAlMg 14µm formed specimen after ACT; the boundary of the layer of corrosion products is shown with white line

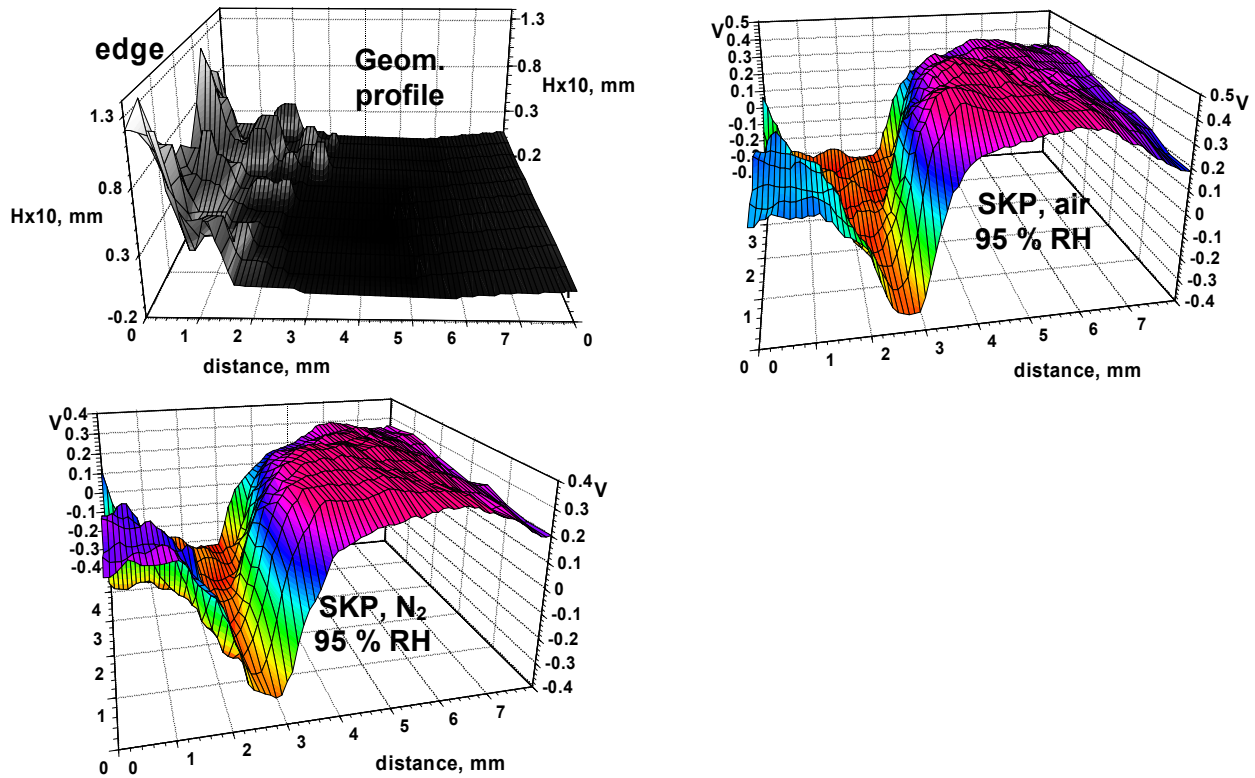
Figure 138 Geometrical and Volta potential profiles for HD ZnAlMg 10 μm in Volvo open configuration exposed in ACT for 18 weeks; measurement was done at the bottom edge (left hand side of profiles)
